Hotelling Gulch Stream Crossing and Channel Realignment Feasibility Study

**Klamath National Forest,
Siskiyou County, California**

PWA Report No. 09082801
April 2010

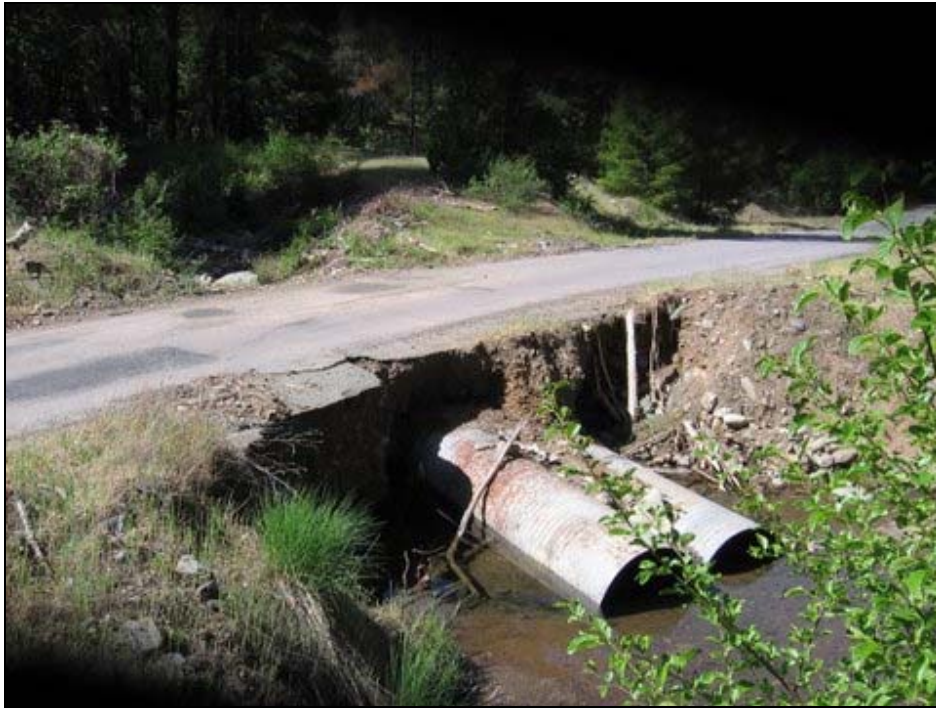
Photo 1. The Hotelling Gulch stream crossing inlet basin after significant storm damage during the winter of 2006.

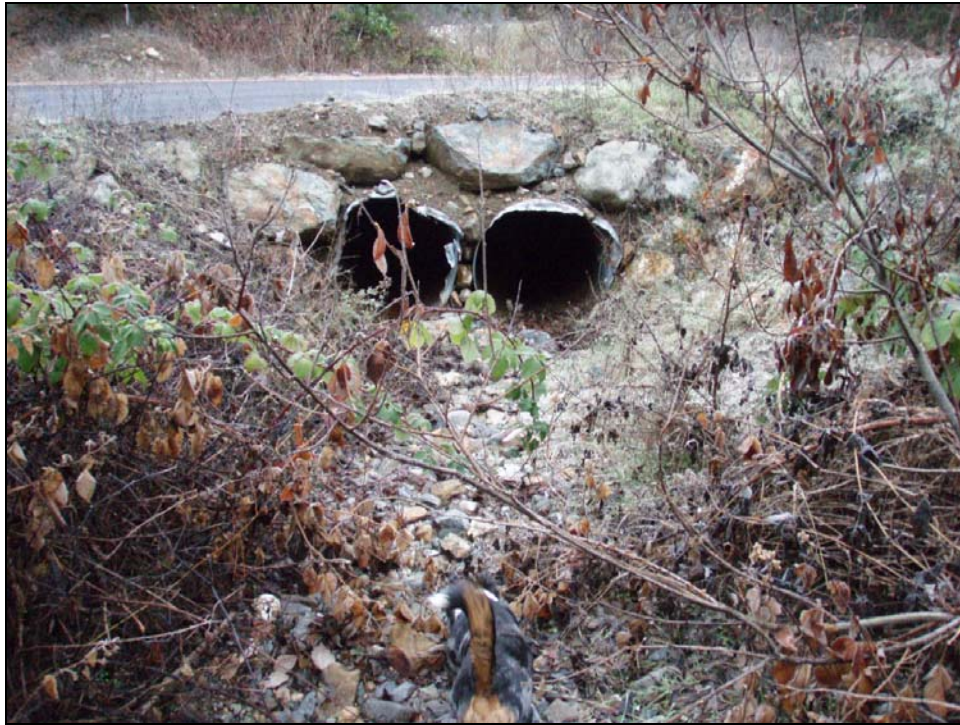
Photo 2. Current view of the inlet basin on the existing (east channel) Cecilville Road crossing.

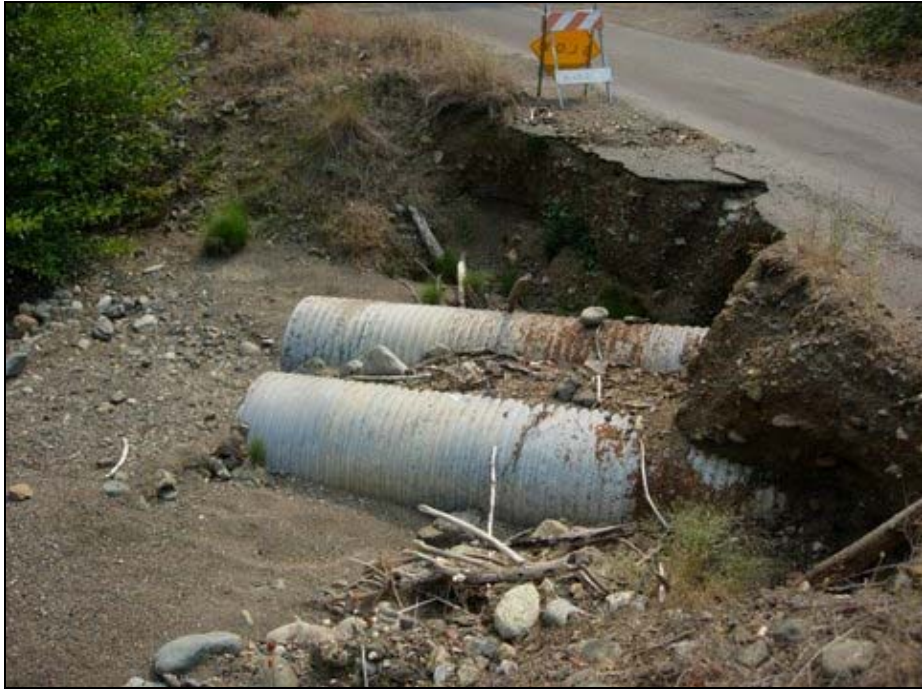
Photo 3. The Hotelling Gulch stream crossing culvert outlets after significant storm damage during the same event as Photo 1 above. Note the recent erosion of the crossing fillslope and sediment deposition filling the channel below.

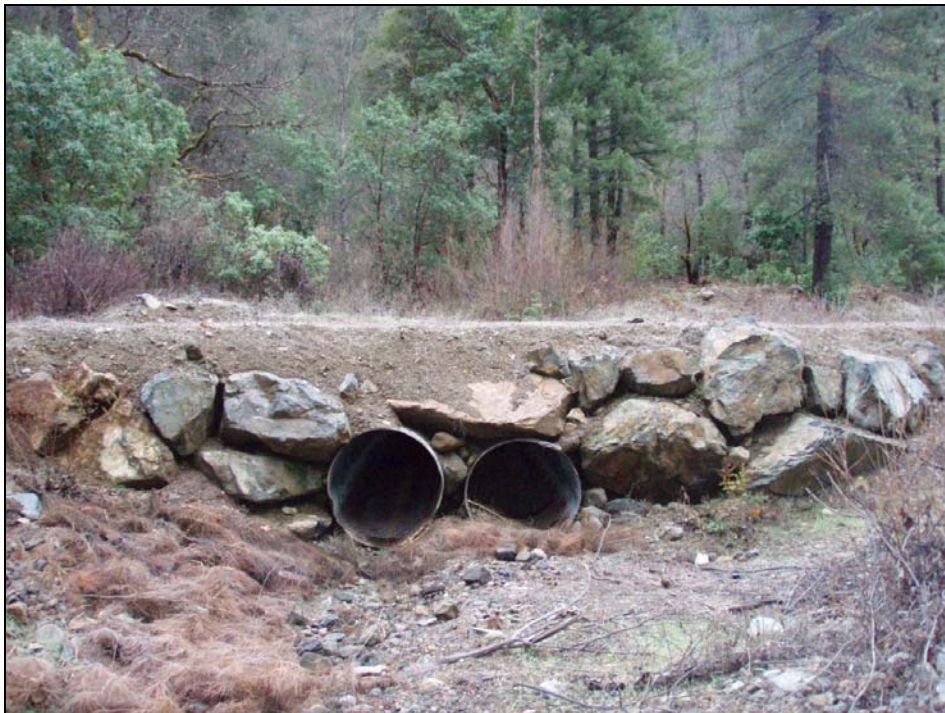
Photo 4. Current view of the culvert outlets on the existing (east channel) Cecilville Road crossing.

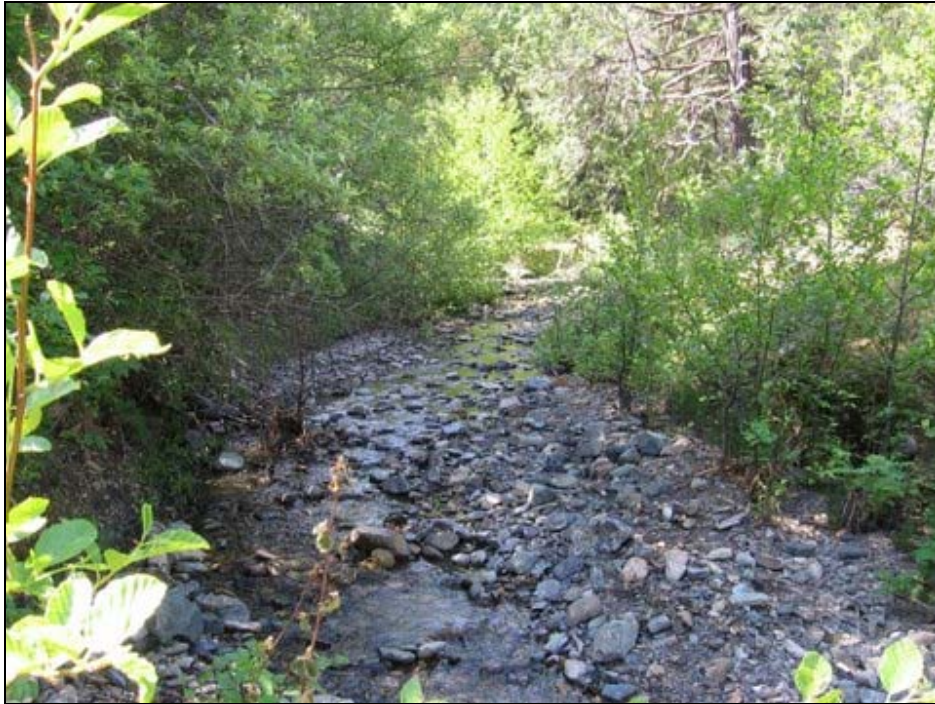
Photo 5. View looking upstream at the active stream channel taken approximately 50 ft above the Hotelling Gulch stream crossing.

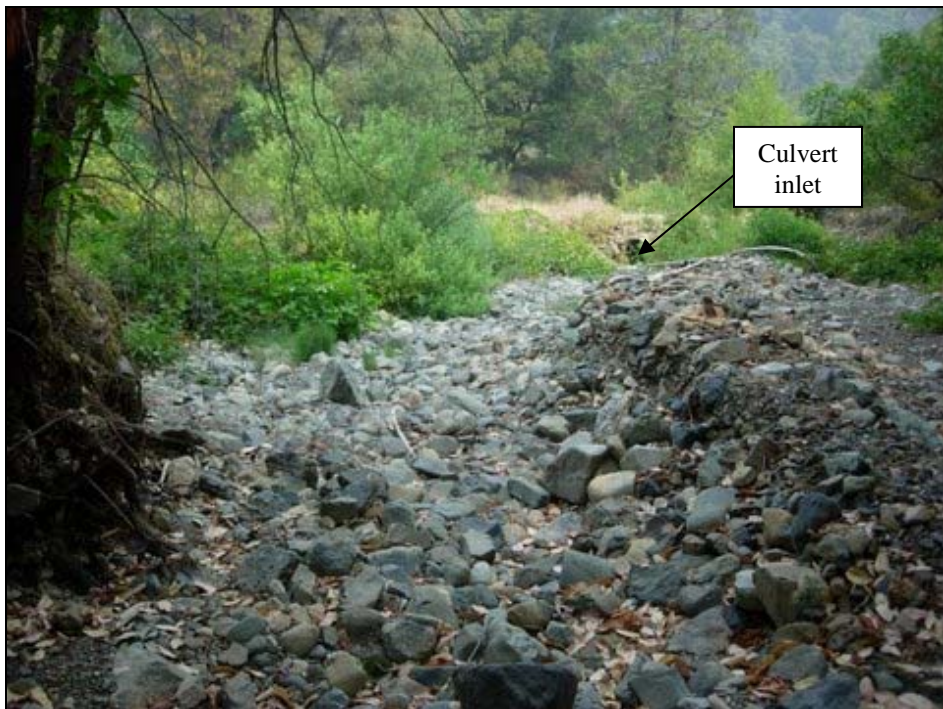
Photo 6. The active stream channel looking downstream at the Hotelling Gulch stream crossing, approaching the culvert inlet basin. Note the recent terrace deposits to the right, likely caused by culvert plugging and backwatering of the stream crossing.

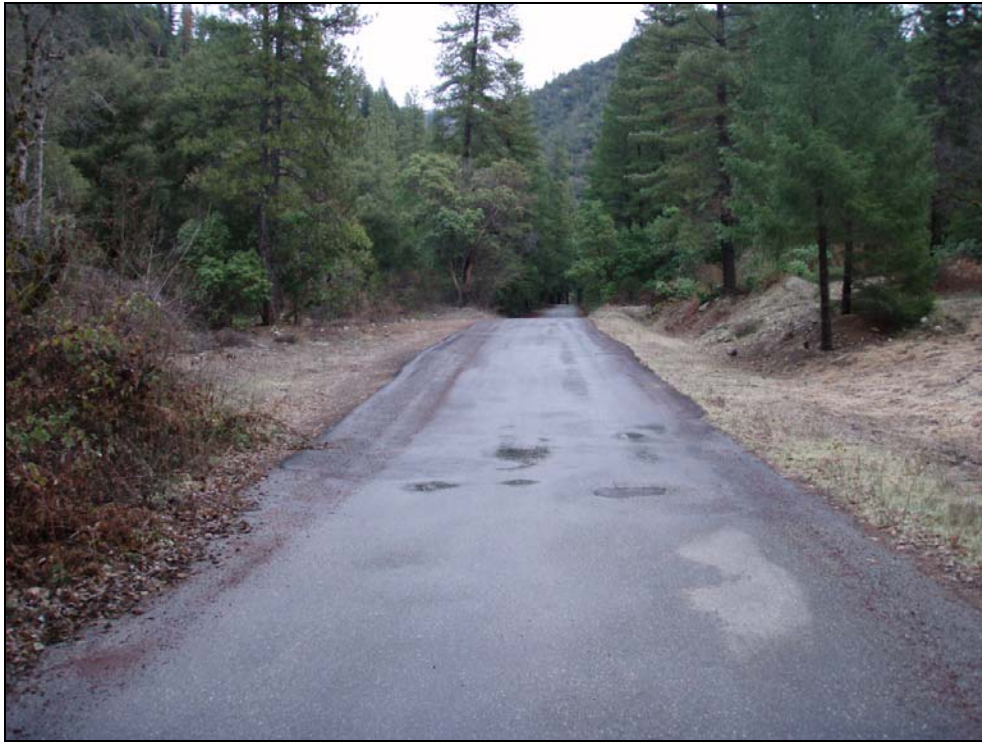
Photo 7. View east up the Cecilville Road; standing at the west channel crossing and looking towards the Hotelling Gulch stream crossing (hump in road).

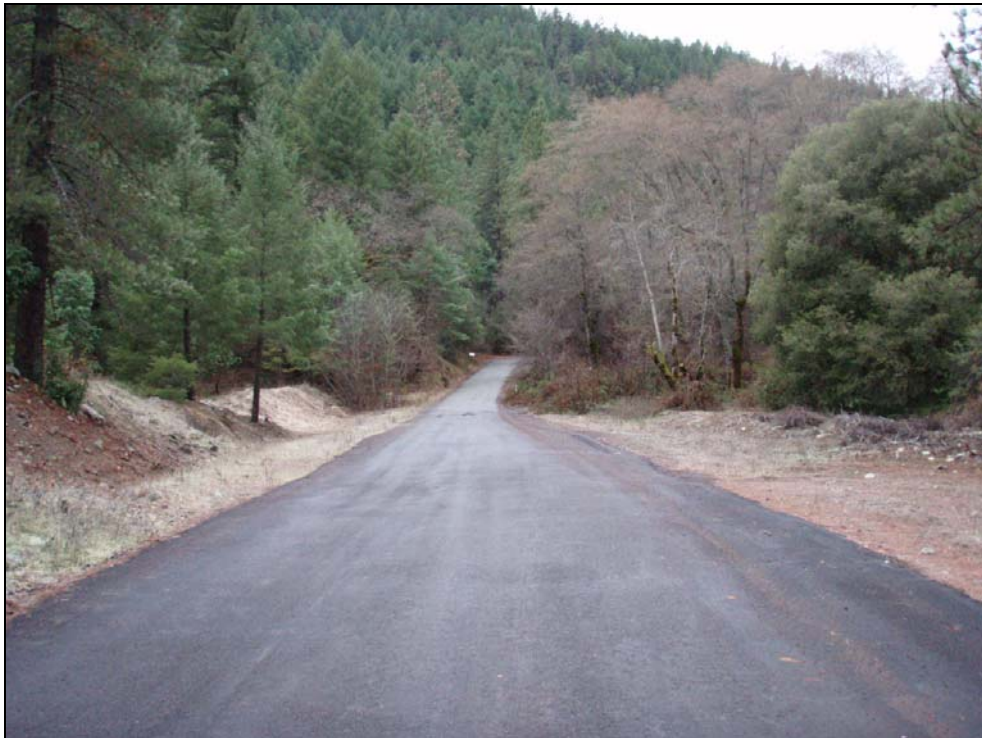
Photo 8. View west down the Cecilville Road; standing at the Hotelling Gulch stream crossing and looking towards the west channel crossing (alder trees at low point in road).

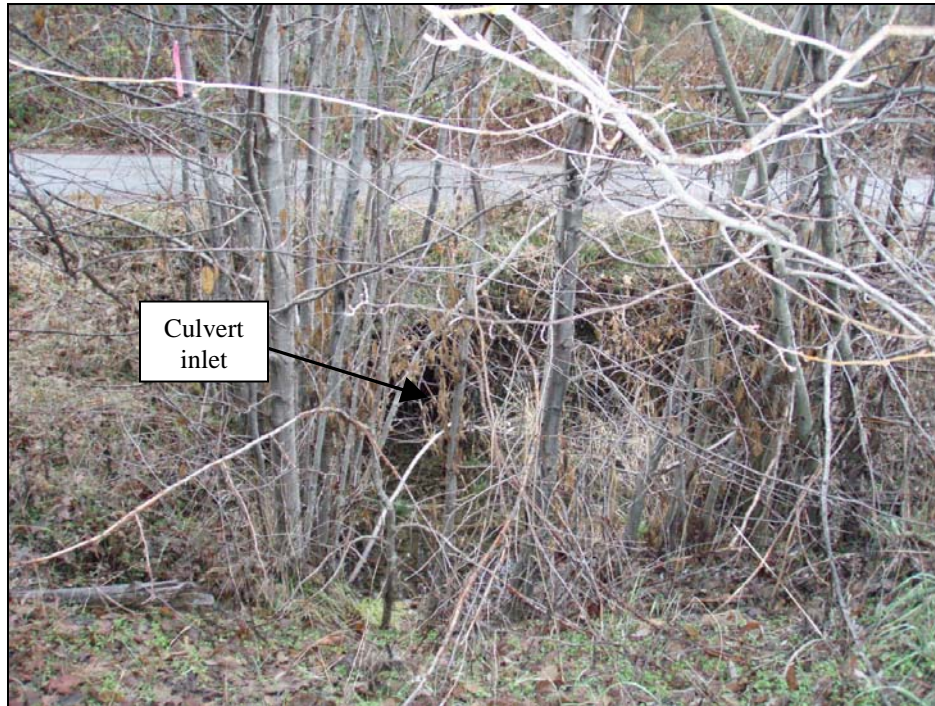
Photo 9. View of culvert inlet basin on the west channel Cecilville Road crossing. Willows constrict view.

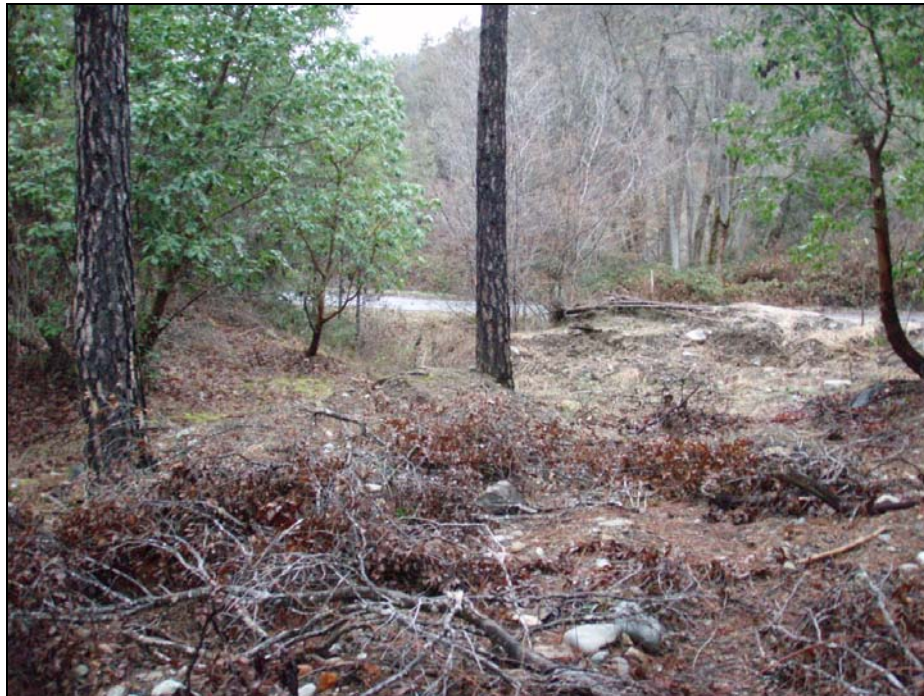
Photo 10. View down the west channel alignment swale towards the crossing on the Cecilville Road. The Cecilville Road culvert lines up just to the left of the Douglas Fir tree in the center of the photo.

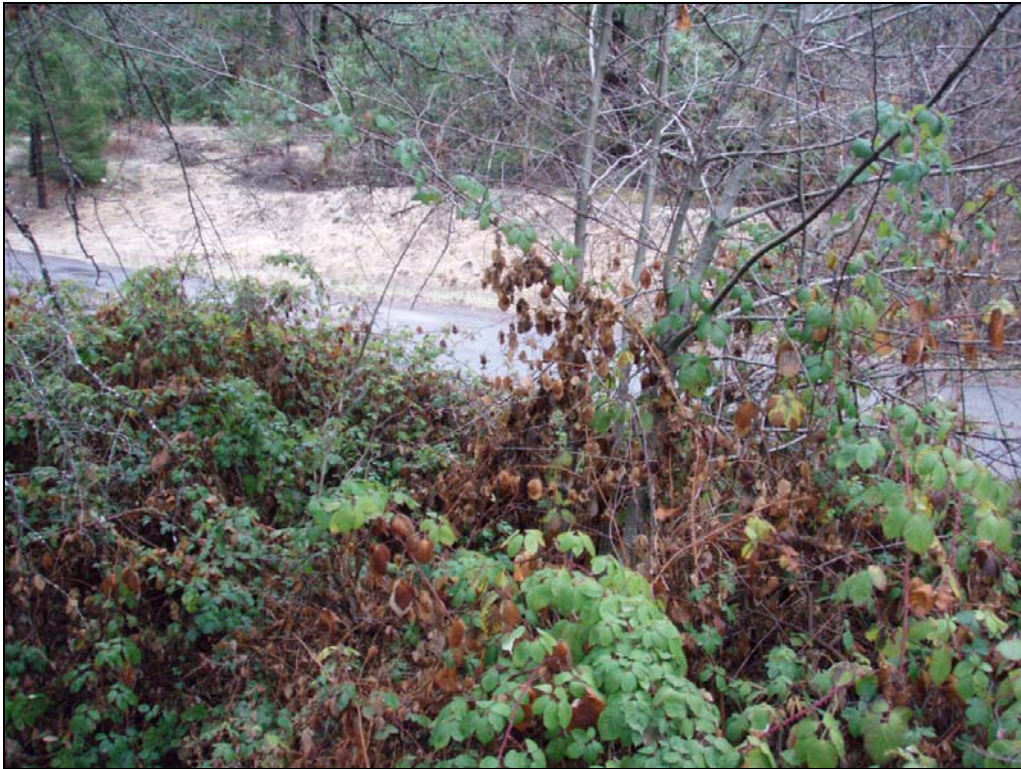
Photo 11. View of culvert outlet area on the west channel Cecilville Road crossing. Willows and blackberry obscure outlet.

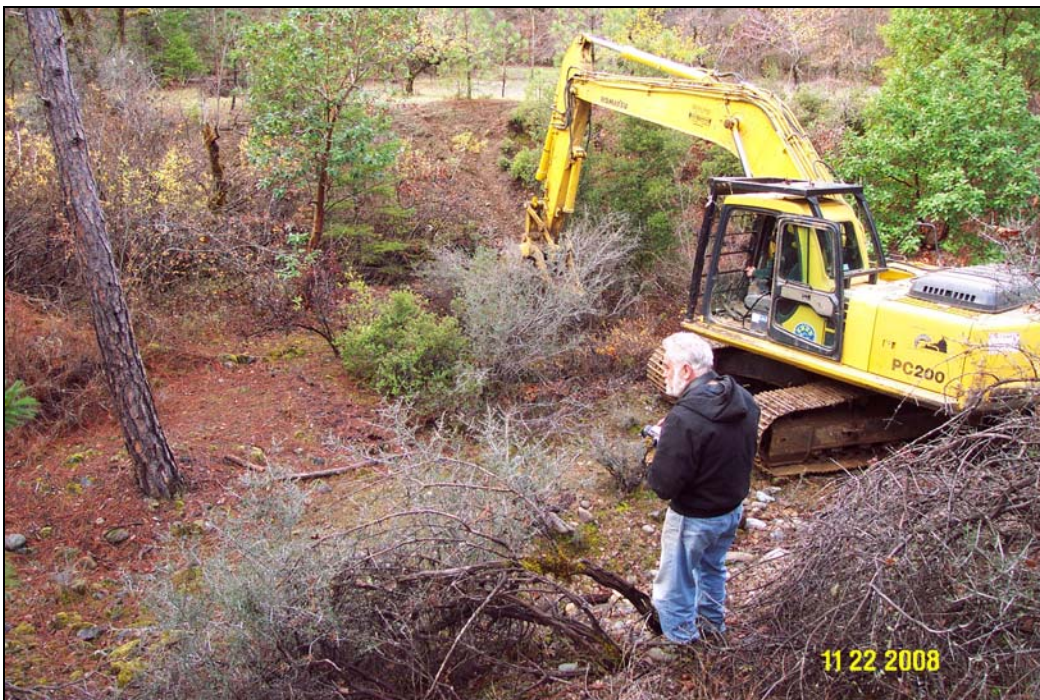
Photo 12. Getting ready to start a new excavation pit along the west alignment above the Cecilville Road.

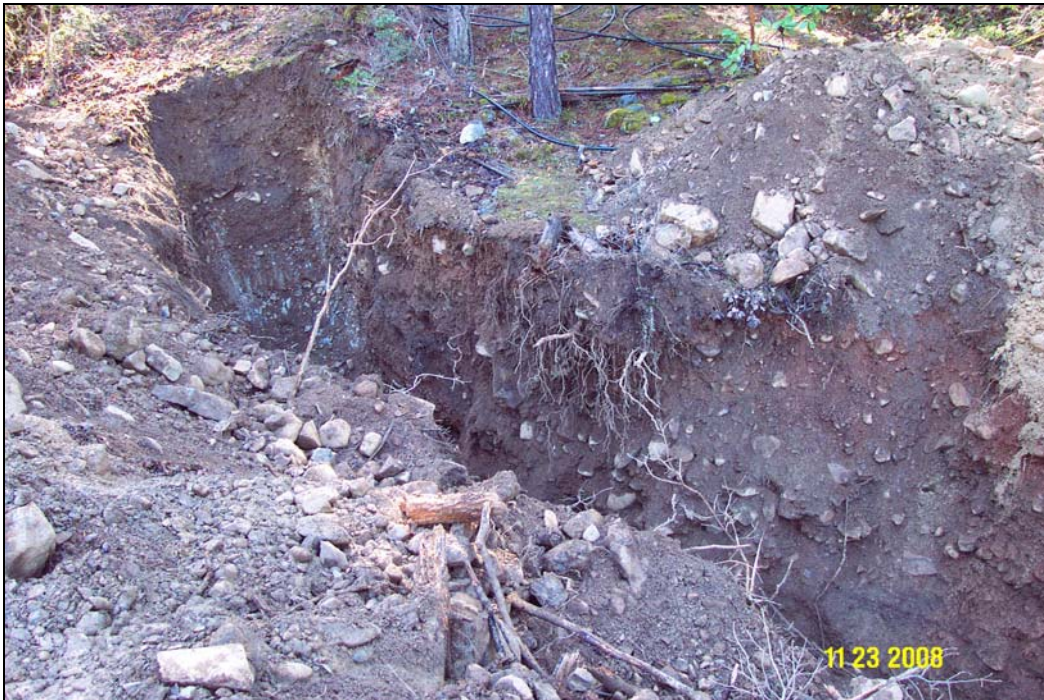
Photo 13. An excavation test pit showing typical stratigraphy; unsorted, heterogeneous alluvial/colluvial deposits that have been reworked by hydraulic mining activities.

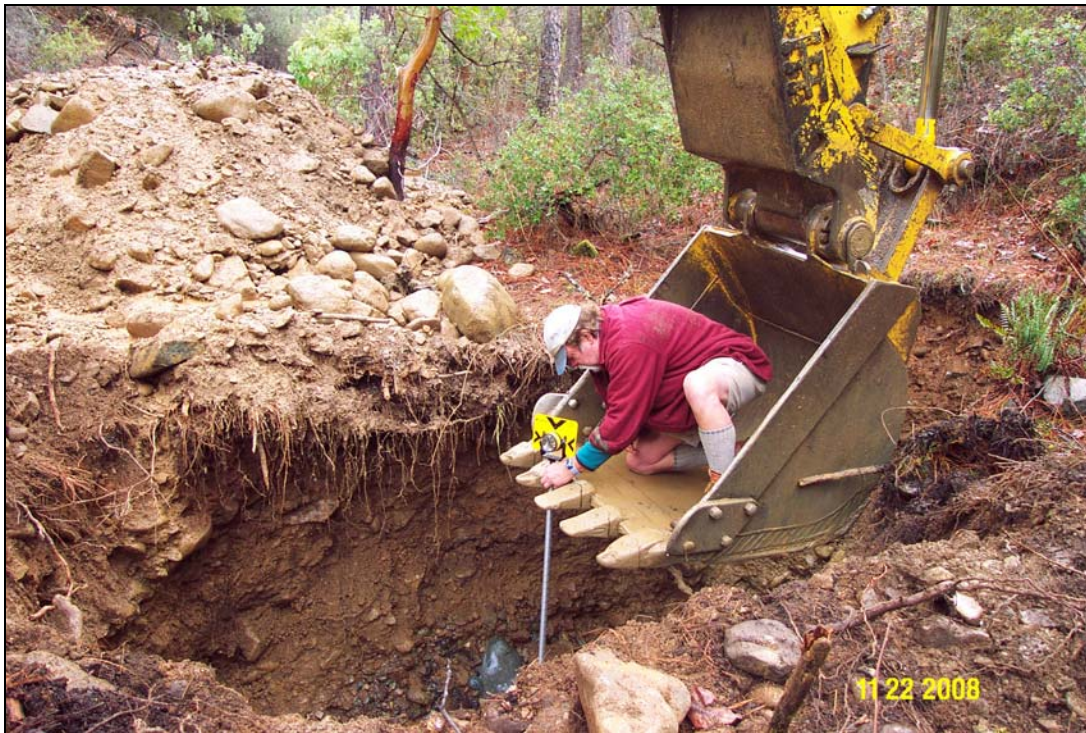
Photo 15. Surveying depth to bedrock and the water table surface in an excavation pit.

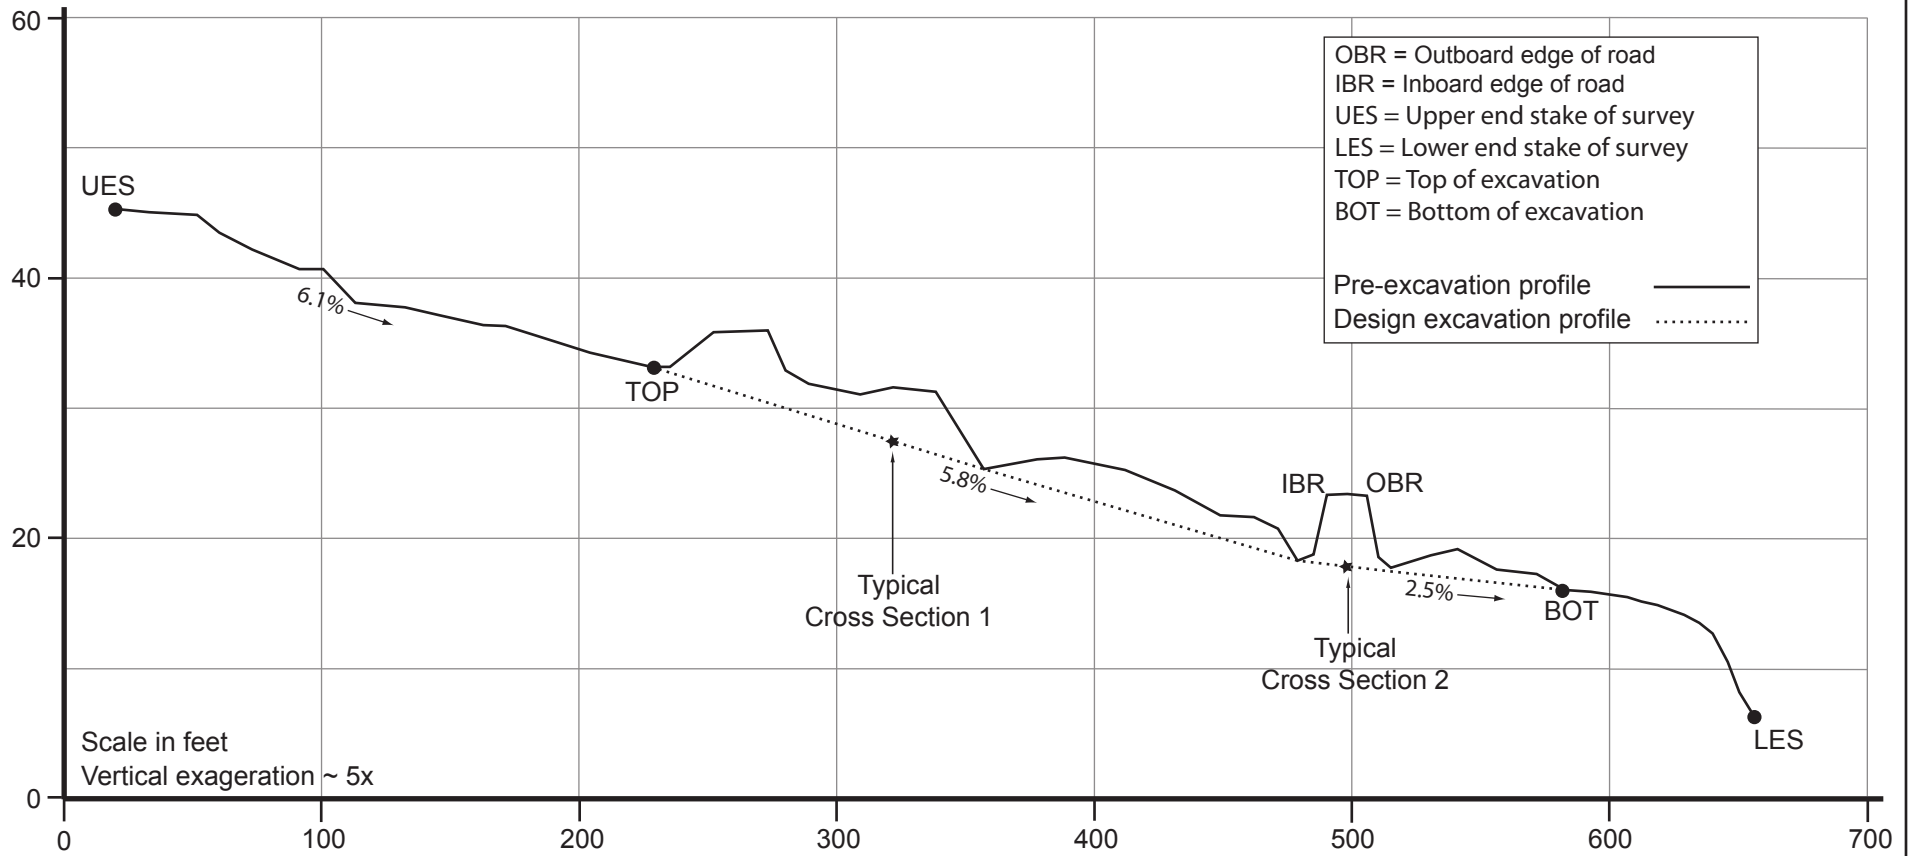
Appendix B, Drawing 4 - Middle Alignment (Alternative IIa)
Channel cross sections pre and post excavation specifications

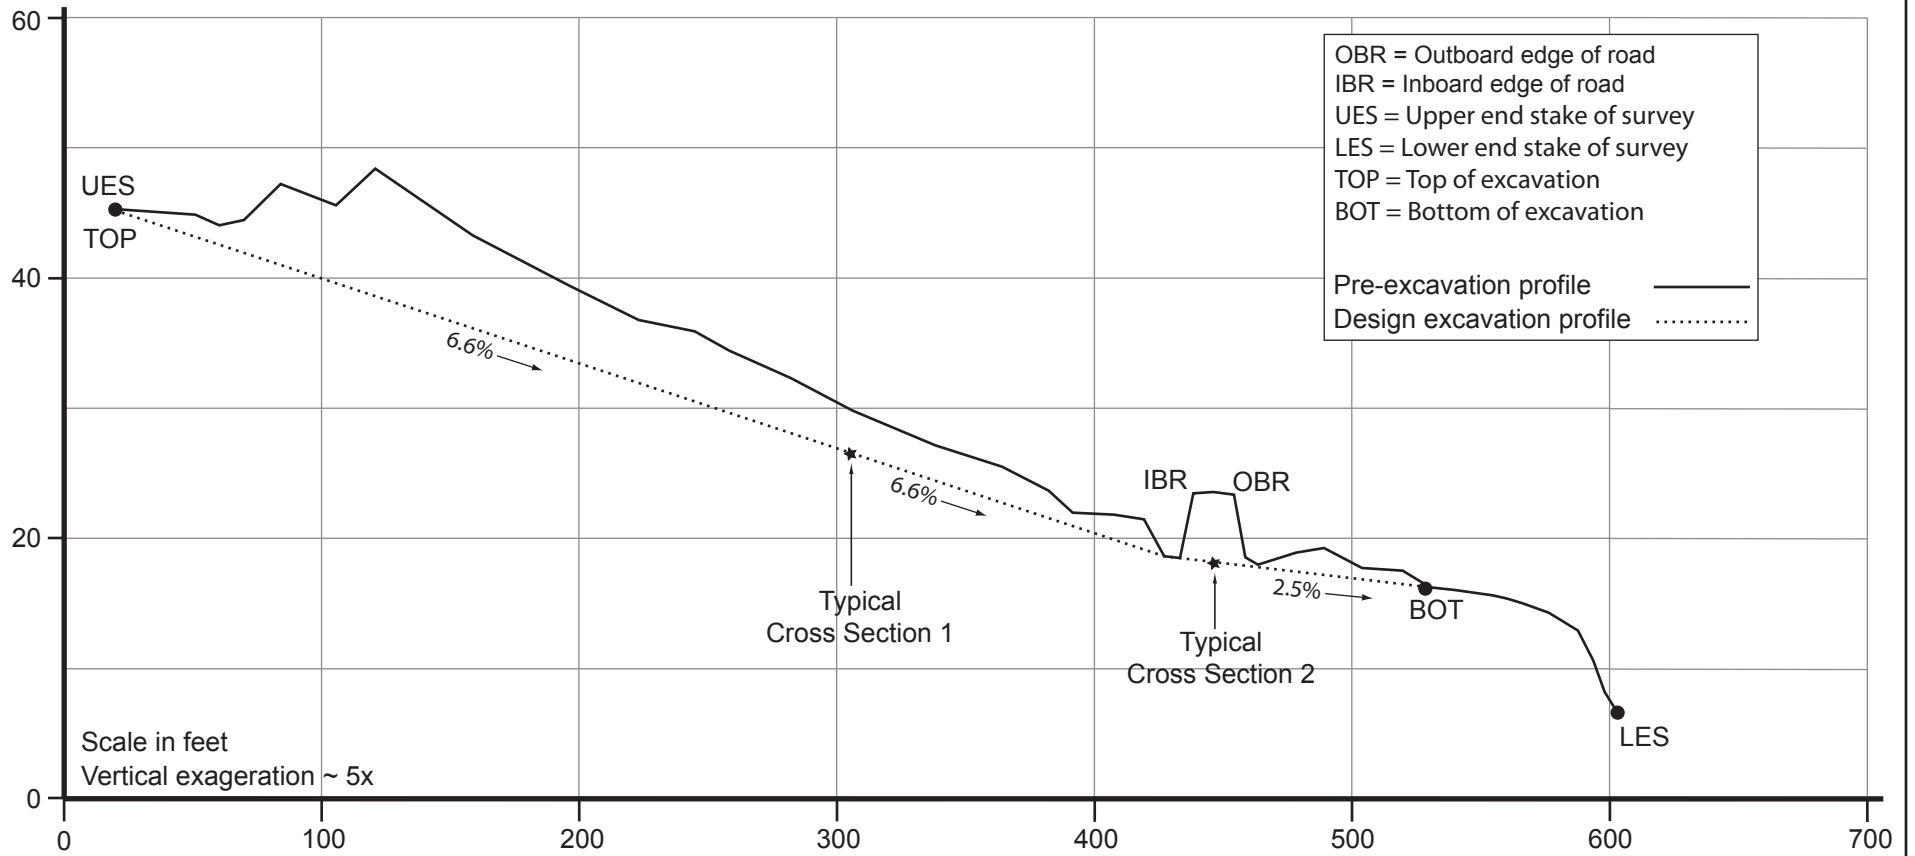
Appendix B, Drawing 6 - West Alignment (Alternative IIb)
Channel cross sections pre and post excavation specifications

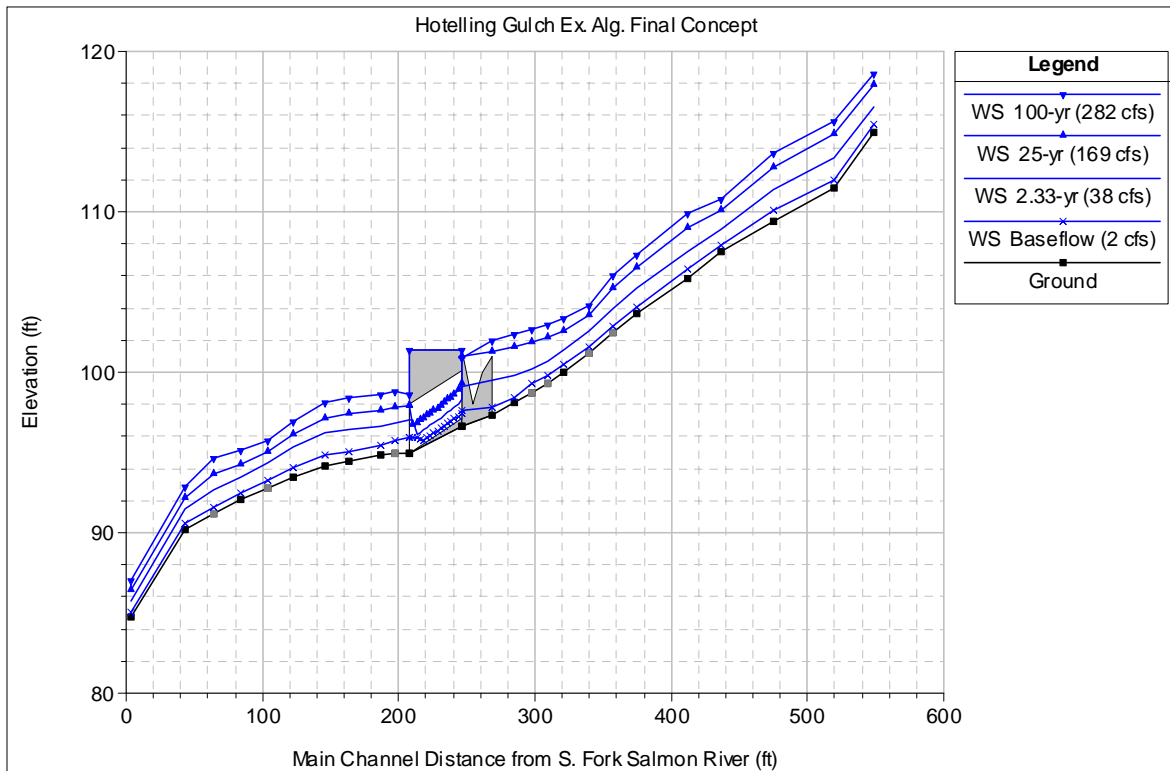
Figure 2. Existing condition water surface profiles at the Cecilville Road crossing of Hotelling Gulch. A lateral weir, shown as a vee upstream of the culvert, controls flow over the left channel bank and out of the system.

Hydraulic modeling results indicate that at flows less than the 2.33-year return period storm, stream flow diverts down the inboard ditch to the left. The volume of stream flow that diverts increases as stream flow increases up until the 50-year return period storm flow event. (MLA report, p. 6; Appendix C). MLA's hydraulic analysis provides estimated return period storm discharges, detailed cross-sectional and channel profile stage height/storm event relations, and channel cross-sectional design requirements based on hydraulic conditions (Appendix C). A final hydraulic analysis will be required during the final design when the most likely alternative is chosen for implementation.

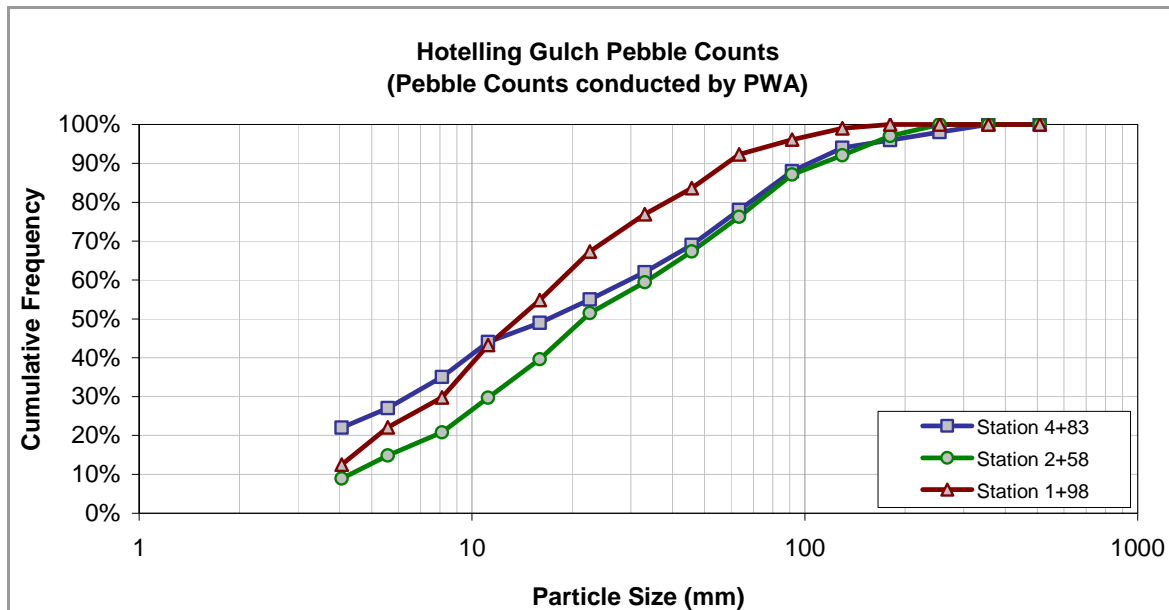
Figure 3. Gradation of channel bed material from pebble counts at three locations on Hotelling Gulch near Cecilville Road.

Pebble Count 1 250 Feet Upstream of Culvert Influence	Pebble Count 2 15-35 Feet Within Influence of Culvert	Pebble Count 3 25-45 Feet Downstream of Culvert
$D_{50} = 0.7$ inches	$D_{50} = 0.9$ inches	$D_{50} = 0.6$ inches
$D_{84} = 3.1$ inches	$D_{84} = 3.2$ inches	$D_{84} = 1.8$ inches

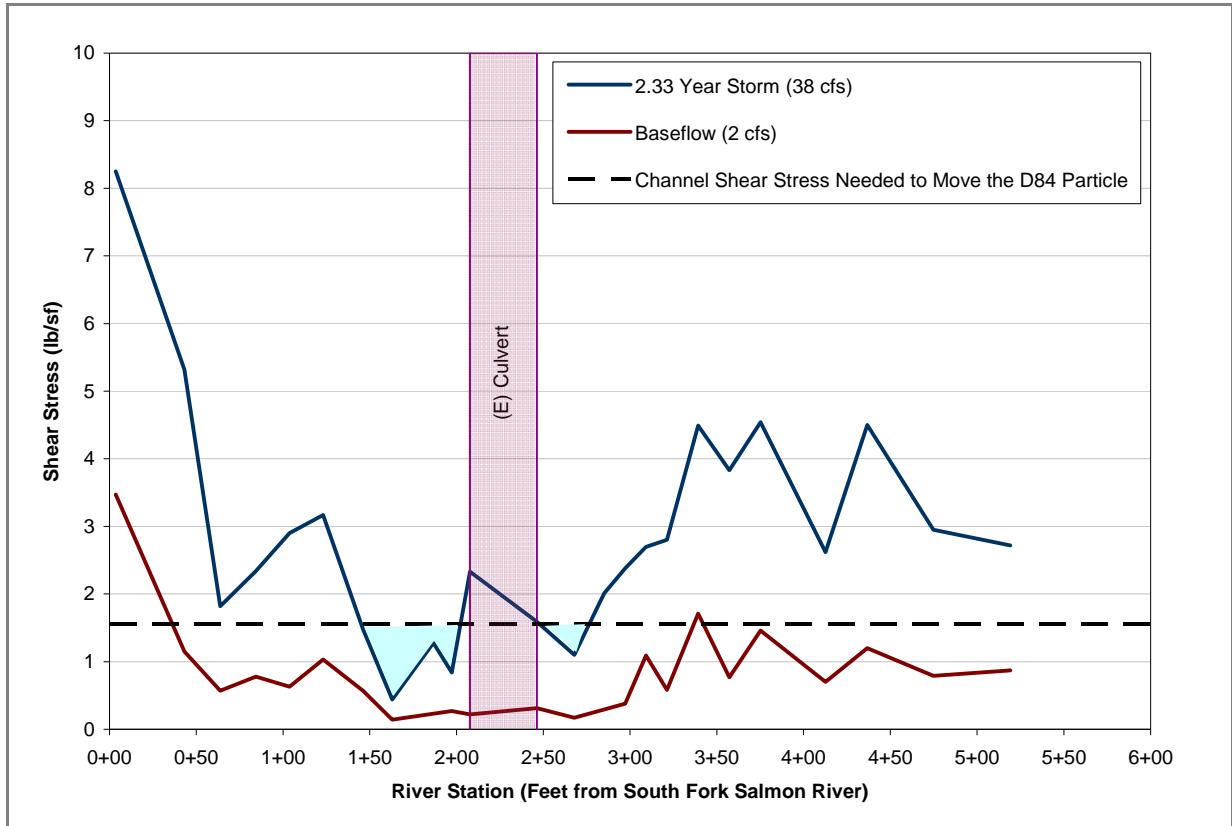
Figure 4. Shear stress at each HEC-RAS cross sections at baseflow and the 2.33-year return period flow. The dashed line represents the channel shear stress necessary to mobilize the D_{84} particle size using a dimensionless shear stress of 0.06. Light blue hatched areas indicate where channel shear stress is insufficient to maintain transport of the D_{84} particle and deposition is expected to occur at the 2.33-year return period flow. The high shear at the confluence with the South Fork Salmon River is in a steeply sloped bedrock chute.

A 3-inch particle size was selected for evaluation of the sediment transport competence of the existing channel based on the results of Pebble Count 1, which was assumed to reflect the size of material delivered to the project reach. This particles size, which reflects the D_{84} of Pebble Count 1, represents the size fraction where 84% of the material comprising the streambed is smaller. If during a commonly occurring flood event the channel reach does not have the competence to transport a 3-inch particle delivered from upstream, deposition of that size particle would be expected. Over time, this could lead to aggradation of the channel bed because of the relative frequency of that particle size.

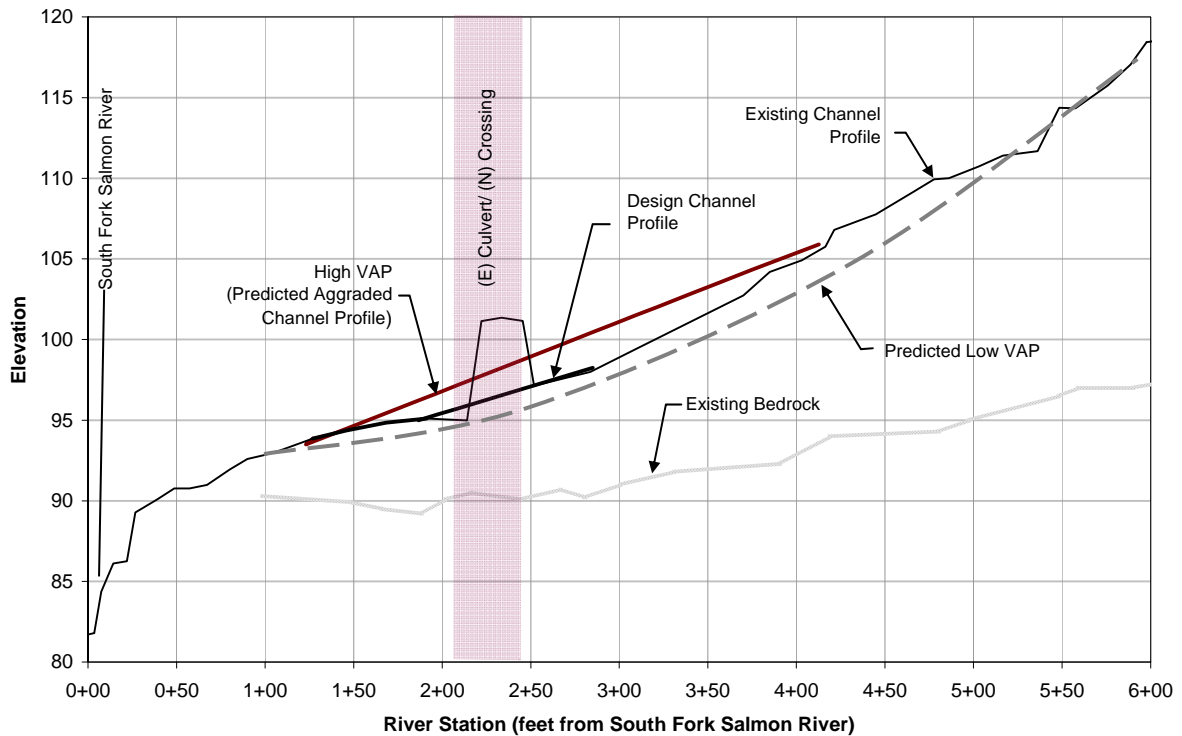
Figure 5. Existing channel profile with predicted low and high Vertical Adjustment Profiles (VAP's). The aggraded channel profile meets the existing channel upstream and downstream of the crossing to create a continuous 4.3% slope. An estimate of the bedrock elevations provided by PWA is also shown.

The predicted 4.3% slope of the aggraded channel forms a uniform channel profile from the upstream sediment delivery reaches, through the crossing, to downstream where the existing channel currently has sufficient sediment transport competence (Figure 5).

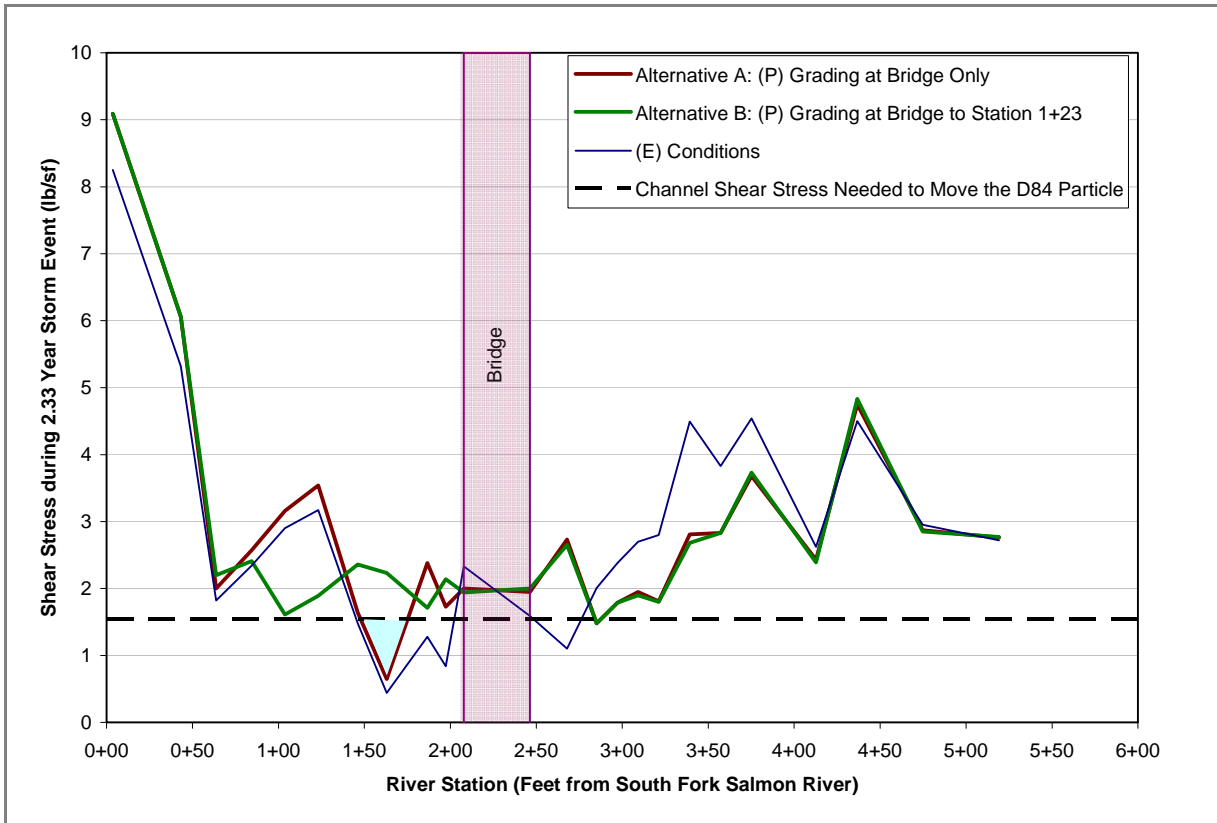
Figure 7. Existing condition and Alternatives A and B shear stress along Hotelling Gulch at a 2.33-year return period flow. The dashed line represents the channel shear stress necessary to mobilize the D_{84} particle size. The light blue hatched area indicates modeling results from Alternative A where channel shear stresses are insufficient to maintain transport of the D_{84} particle and aggradation may occur.

The downstream limits of grading were developed iteratively for Alternative B, extending the limits of grading downstream from the bridge to where channel sediment transport competence for D_{84} particle is maintained downstream to the confluence. Bottom widths of cross sections downstream of station 1+62 transition to 10 feet wide, which more closely matches the existing channel width. Modeling indicated that channel grading needs to extend downstream of the new bridge for approximately 100 feet to maintain sediment transport continuity (Figure 7).

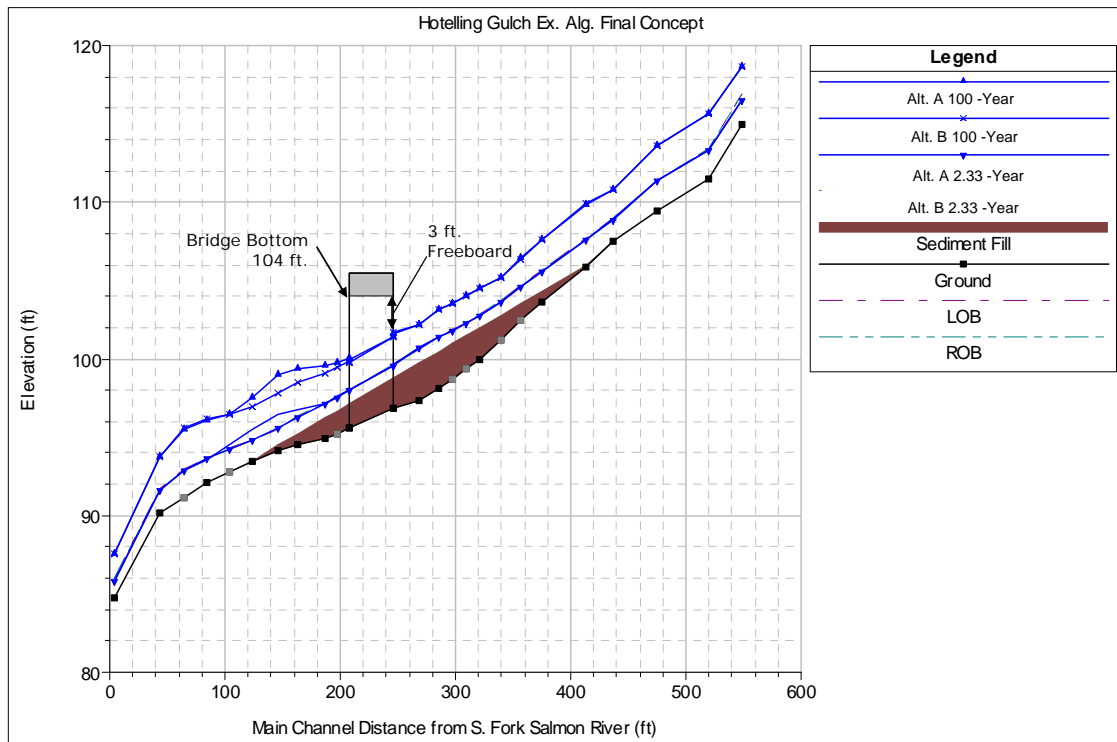
Figure 8. Profile of 2.33 and 100-year water surface profiles for Alternatives A and B. Note that the water surface profile for both alternatives are similar, except downstream of the bridge, where in Alternative A, a backwater occurs between station 1+23 and the bridge.

Hotelling Gulch has experienced extensive debris loading in the past, with quantities of large trees and boulders jamming the channel during high flows. Based on this, we recommend a minimum of 3 feet of freeboard be provided above the 100-year water surface elevation, placing the bottom of the bridge deck 5 feet above the aggraded channel bottom at the high VAP. This places the bottom of the bridge crossing at an elevation of 104 feet, necessitating a free-span of approximately 35 feet across the channel (Figure 8 and Figure 9).

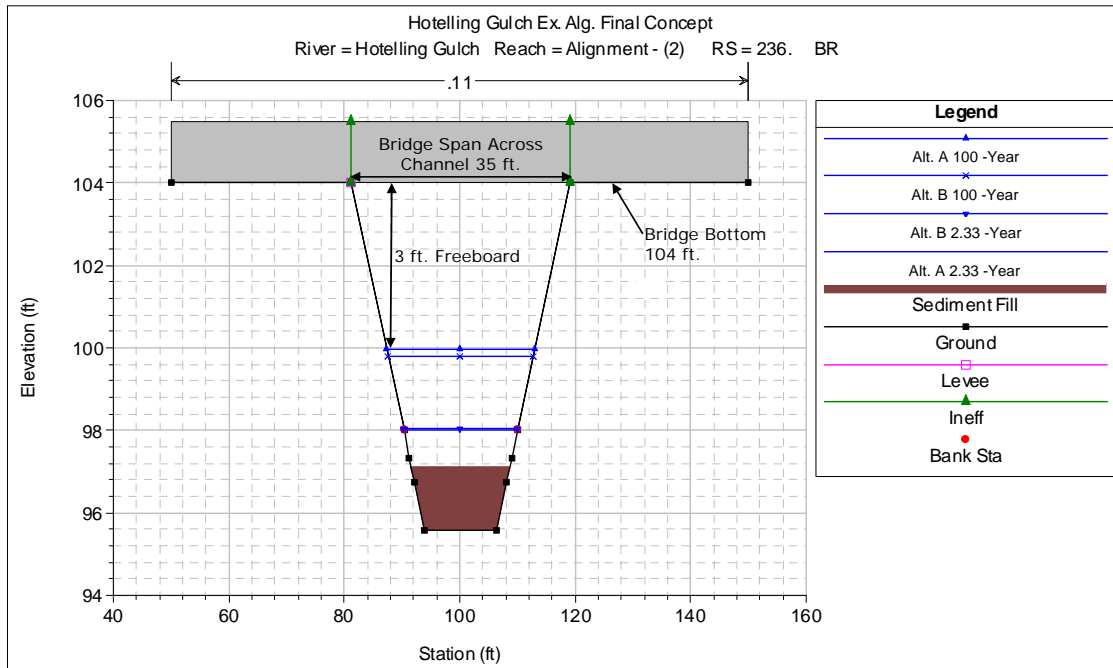
Figure 9. HEC-RAS representation of the proposed channel cross section and bridge crossing at the Cecilville Road crossing of Hotelling Gulch.

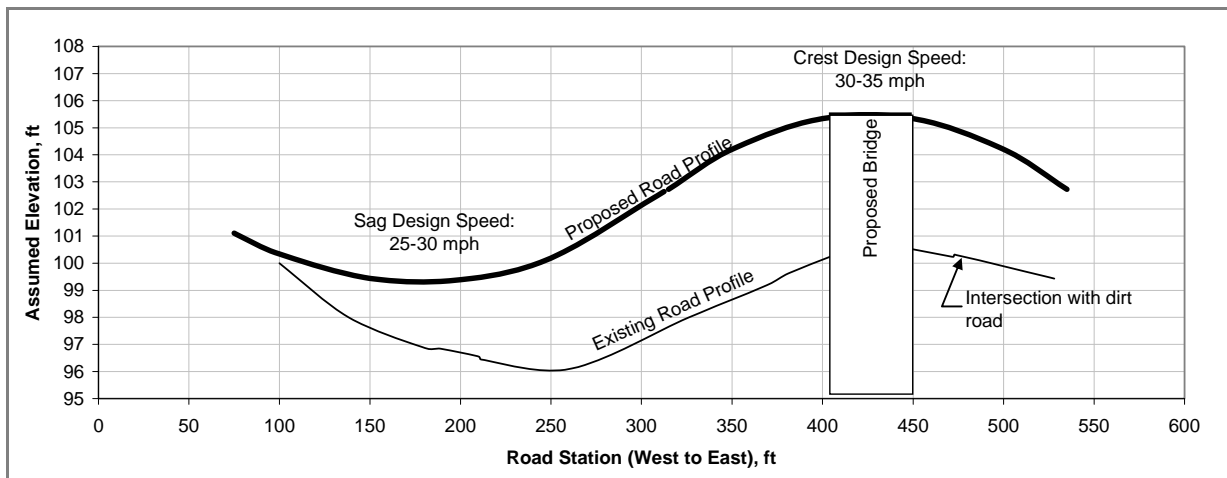
Figure 10. Proposed road profile and design speeds, as compared with the existing profile (vertically exaggerated).

Cecilville Road at Hotelling Gulch is a two-lane road. Standard land width is 12 feet, requiring a minimum road width of 24 feet with standard sections of guardrail on the bridge and bridge approaches.
