**Salmon River Private Roads Sediment Reduction
Project, Klamath Watershed Restoration Program,
Siskiyou County, California**

PWA Report No. 10087801
June 2011

**U.S. Department of the Interior
Bureau of Reclamation
Assistance Agreement # R10AP20601**

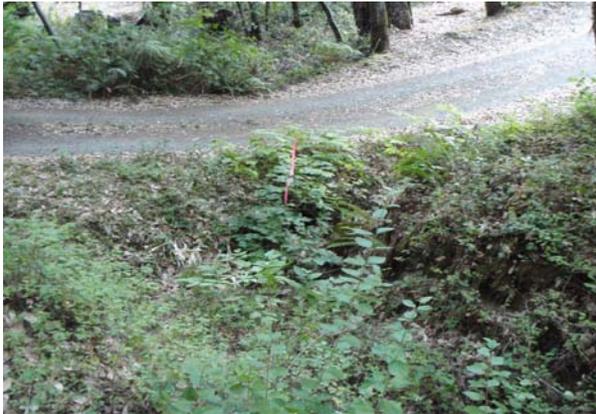
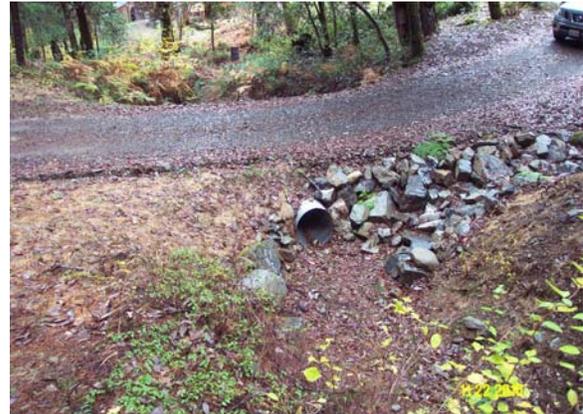
COVER PHOTOS: Before and after photos showing an undersized and rusted culvert set high in the fill having been replaced with a properly sized culvert set at natural channel grade and alignment at site #102 on Butler Loop Road, Butler Flat Treatment Area. The left photo was taken before replacement in 2009 and the right photo was taken after work was completed and the site was subjected to the 2nd season's rainfall in 2010.

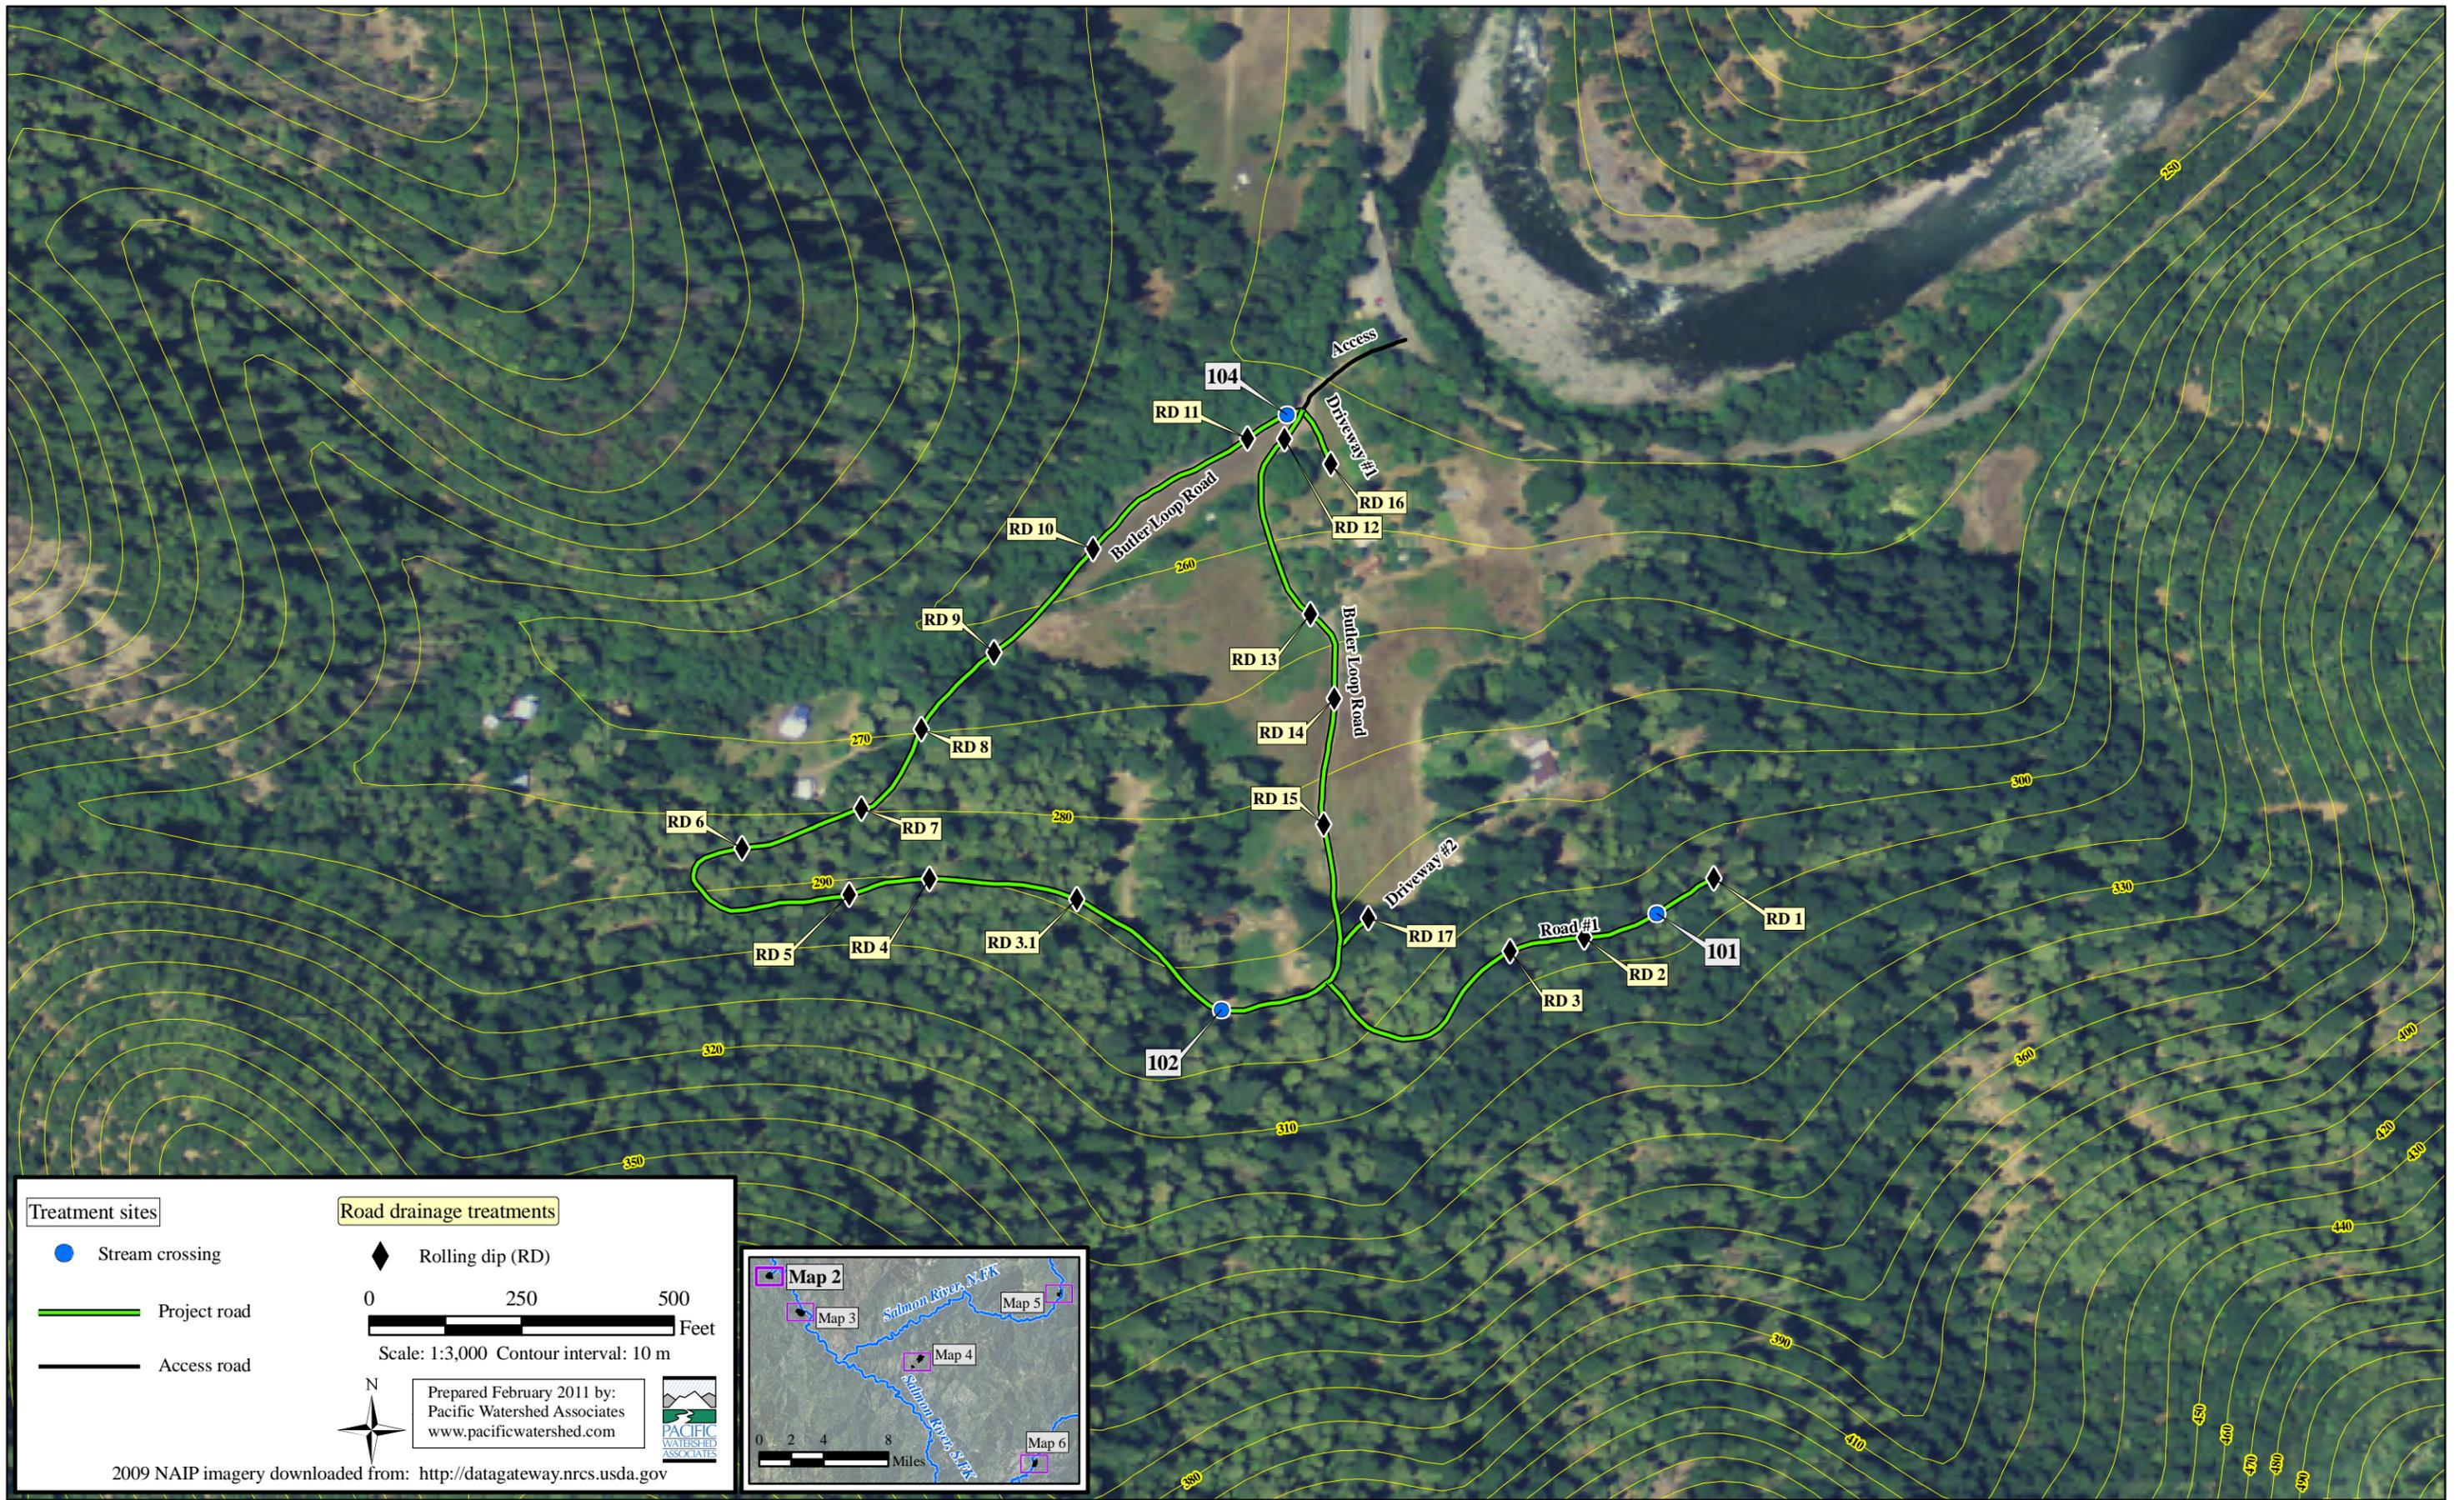
Map 2. Butler Flat Treatment Area Map, Salmon River Private Roads Sediment Reduction Project, Siskiyou County, California.

1. **Butler Flat:** Work on the Butler Flat area included 4 separate roads; a 0.68mi long loop in the north-central part of the property, a 0.16mi spur road in the eastern portion of the property, and two short driveways totaling 0.05mi (Map 2). All roads within the Butler property were upgraded.

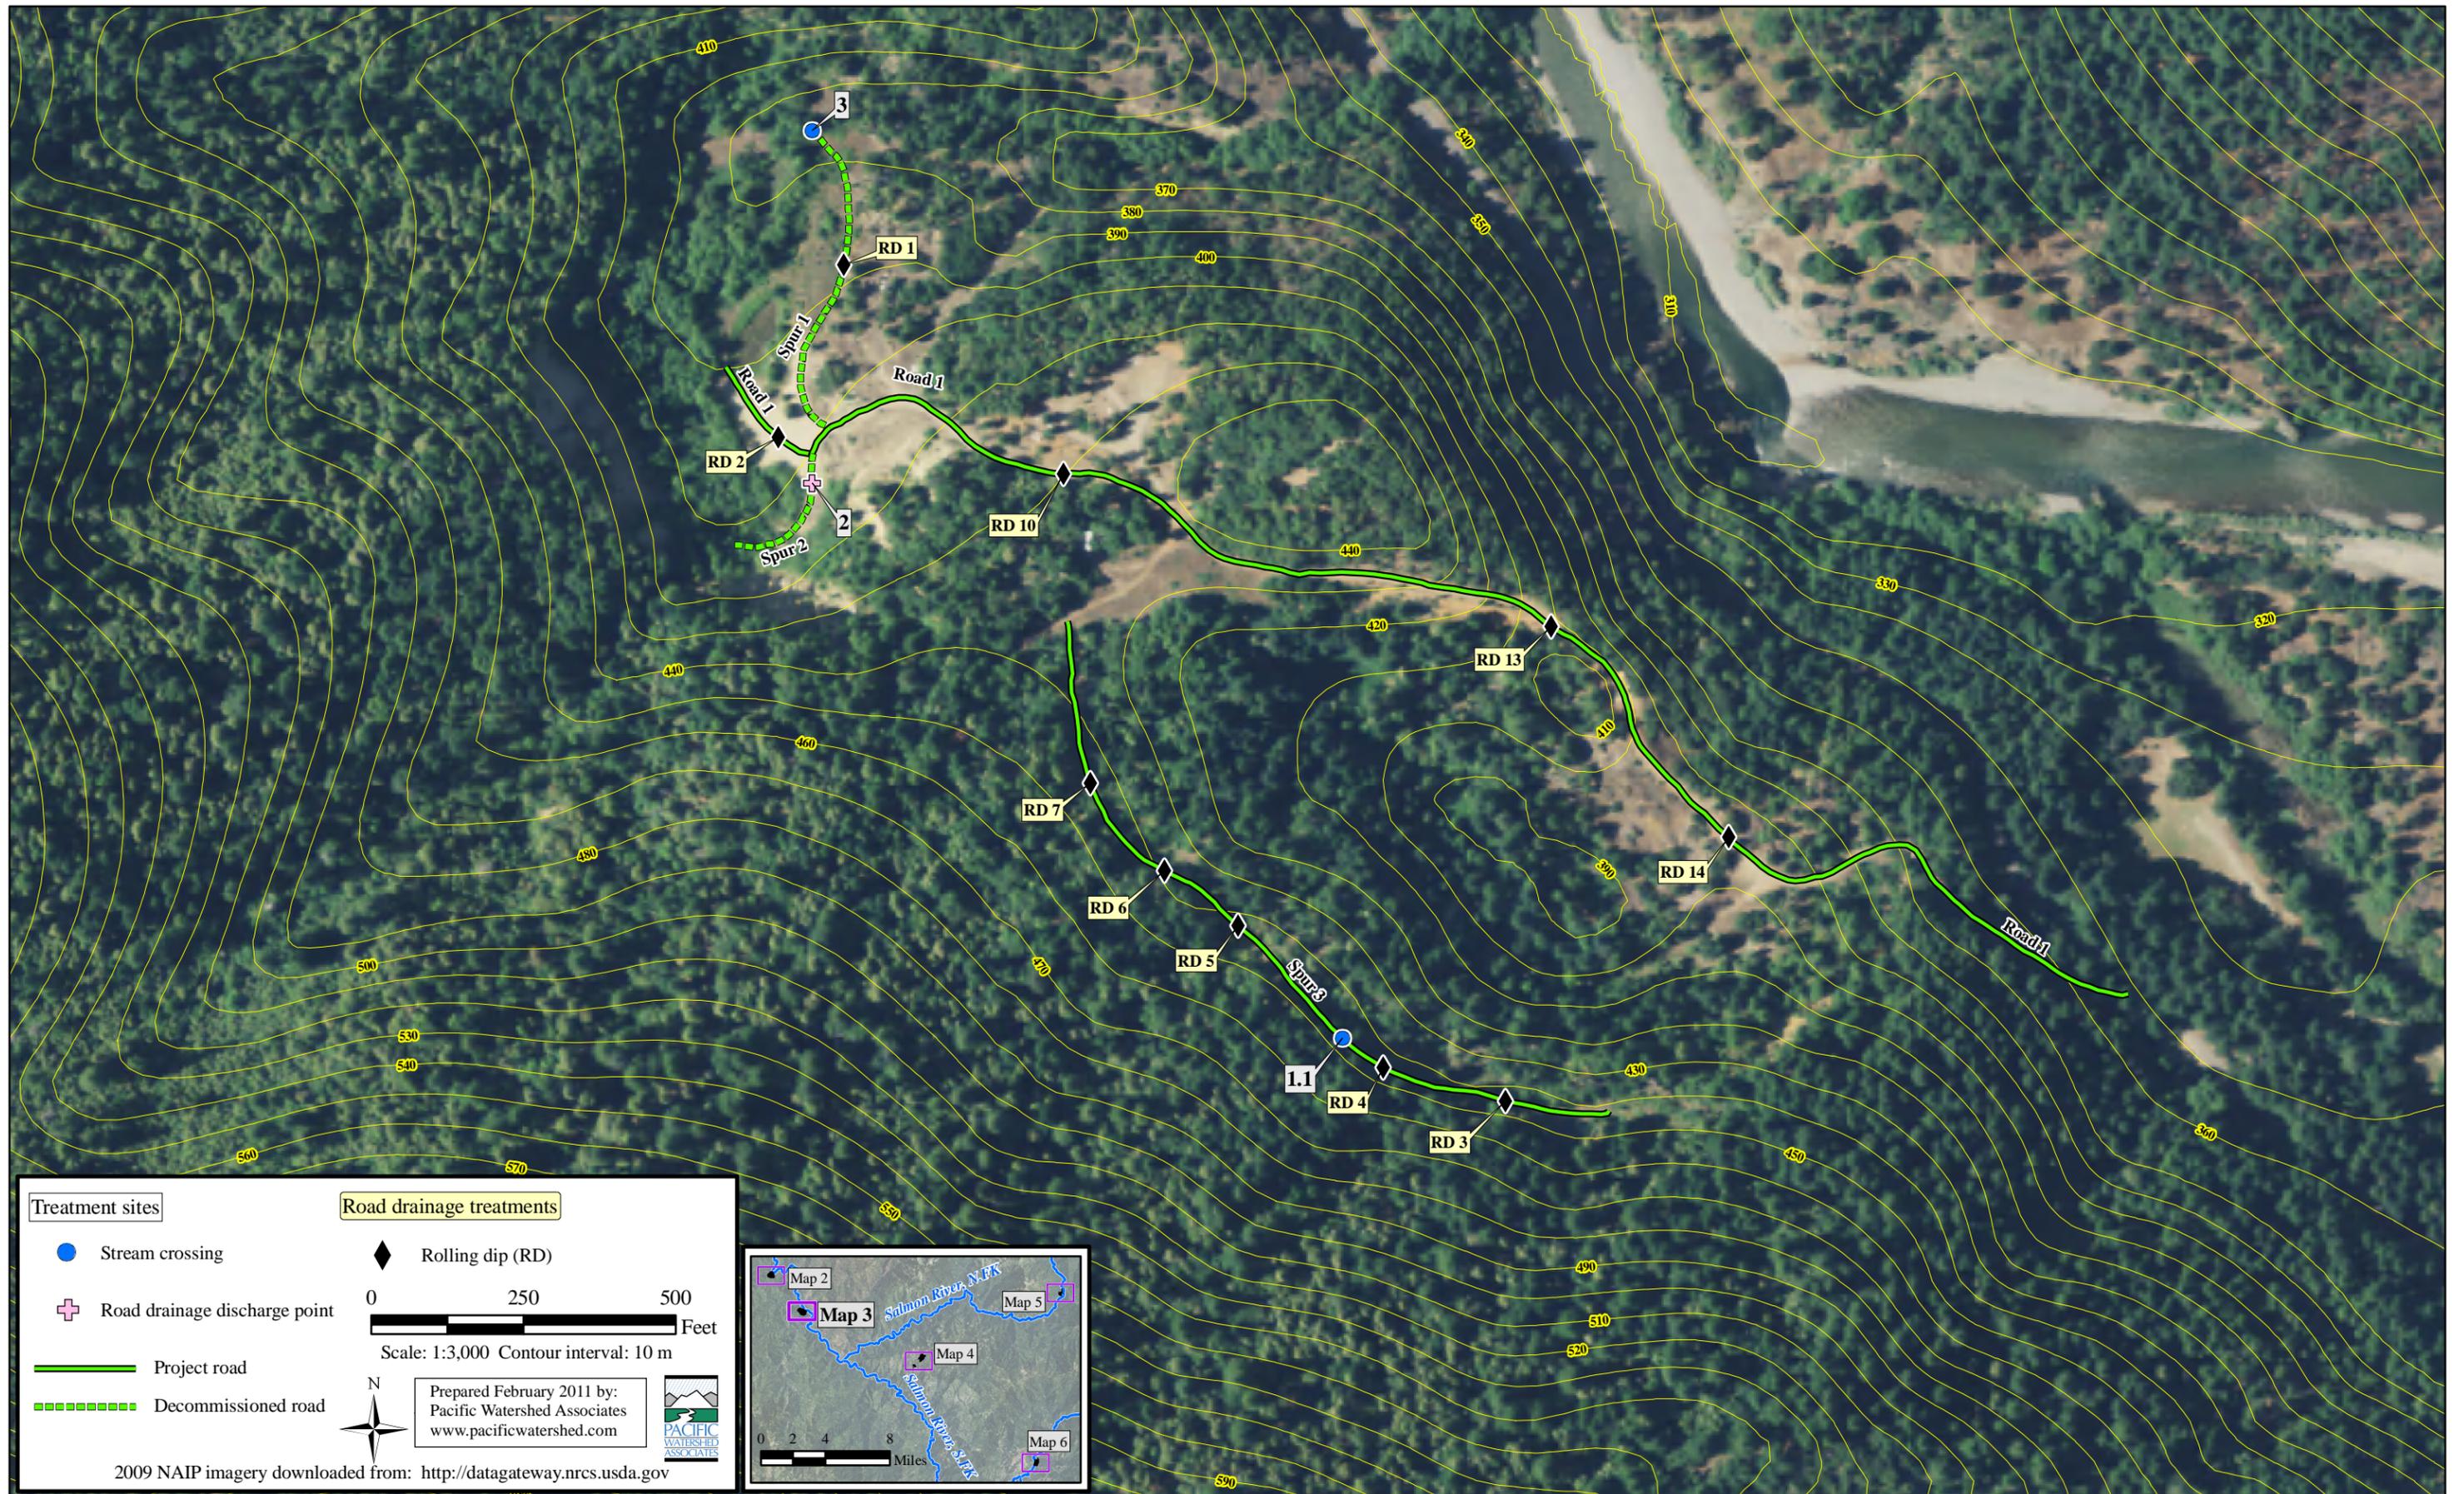
Map 3. Bloomer Mine Treatment Area Map, Salmon River Private Roads Sediment Reduction Project, Siskiyou County, California.

2. **Bloomer Mine:** Work on the Bloomer Mine area included 4 separate roads; 1 main access road and 3 short spur roads (Map 3). Road #1 is the main access road through the property and is 0.36mi long from the intersection with Salmon River Road to its terminus adjacent to a small pond near the northwestern property boundary. Spur #1 Road is a 0.09mi long spur road adjacent to a small pond in the northwest portion of the property. Spur #2 Road is a 0.01mi long spur road in the northwest portion of the property. Spur #3 Road is a 0.27mi long spur road from the intersection with Road #1 to its terminus at a

small landing. Road #1 and Spur #3 were upgraded for this project while Spurs 1 and 2 were both decommissioned.

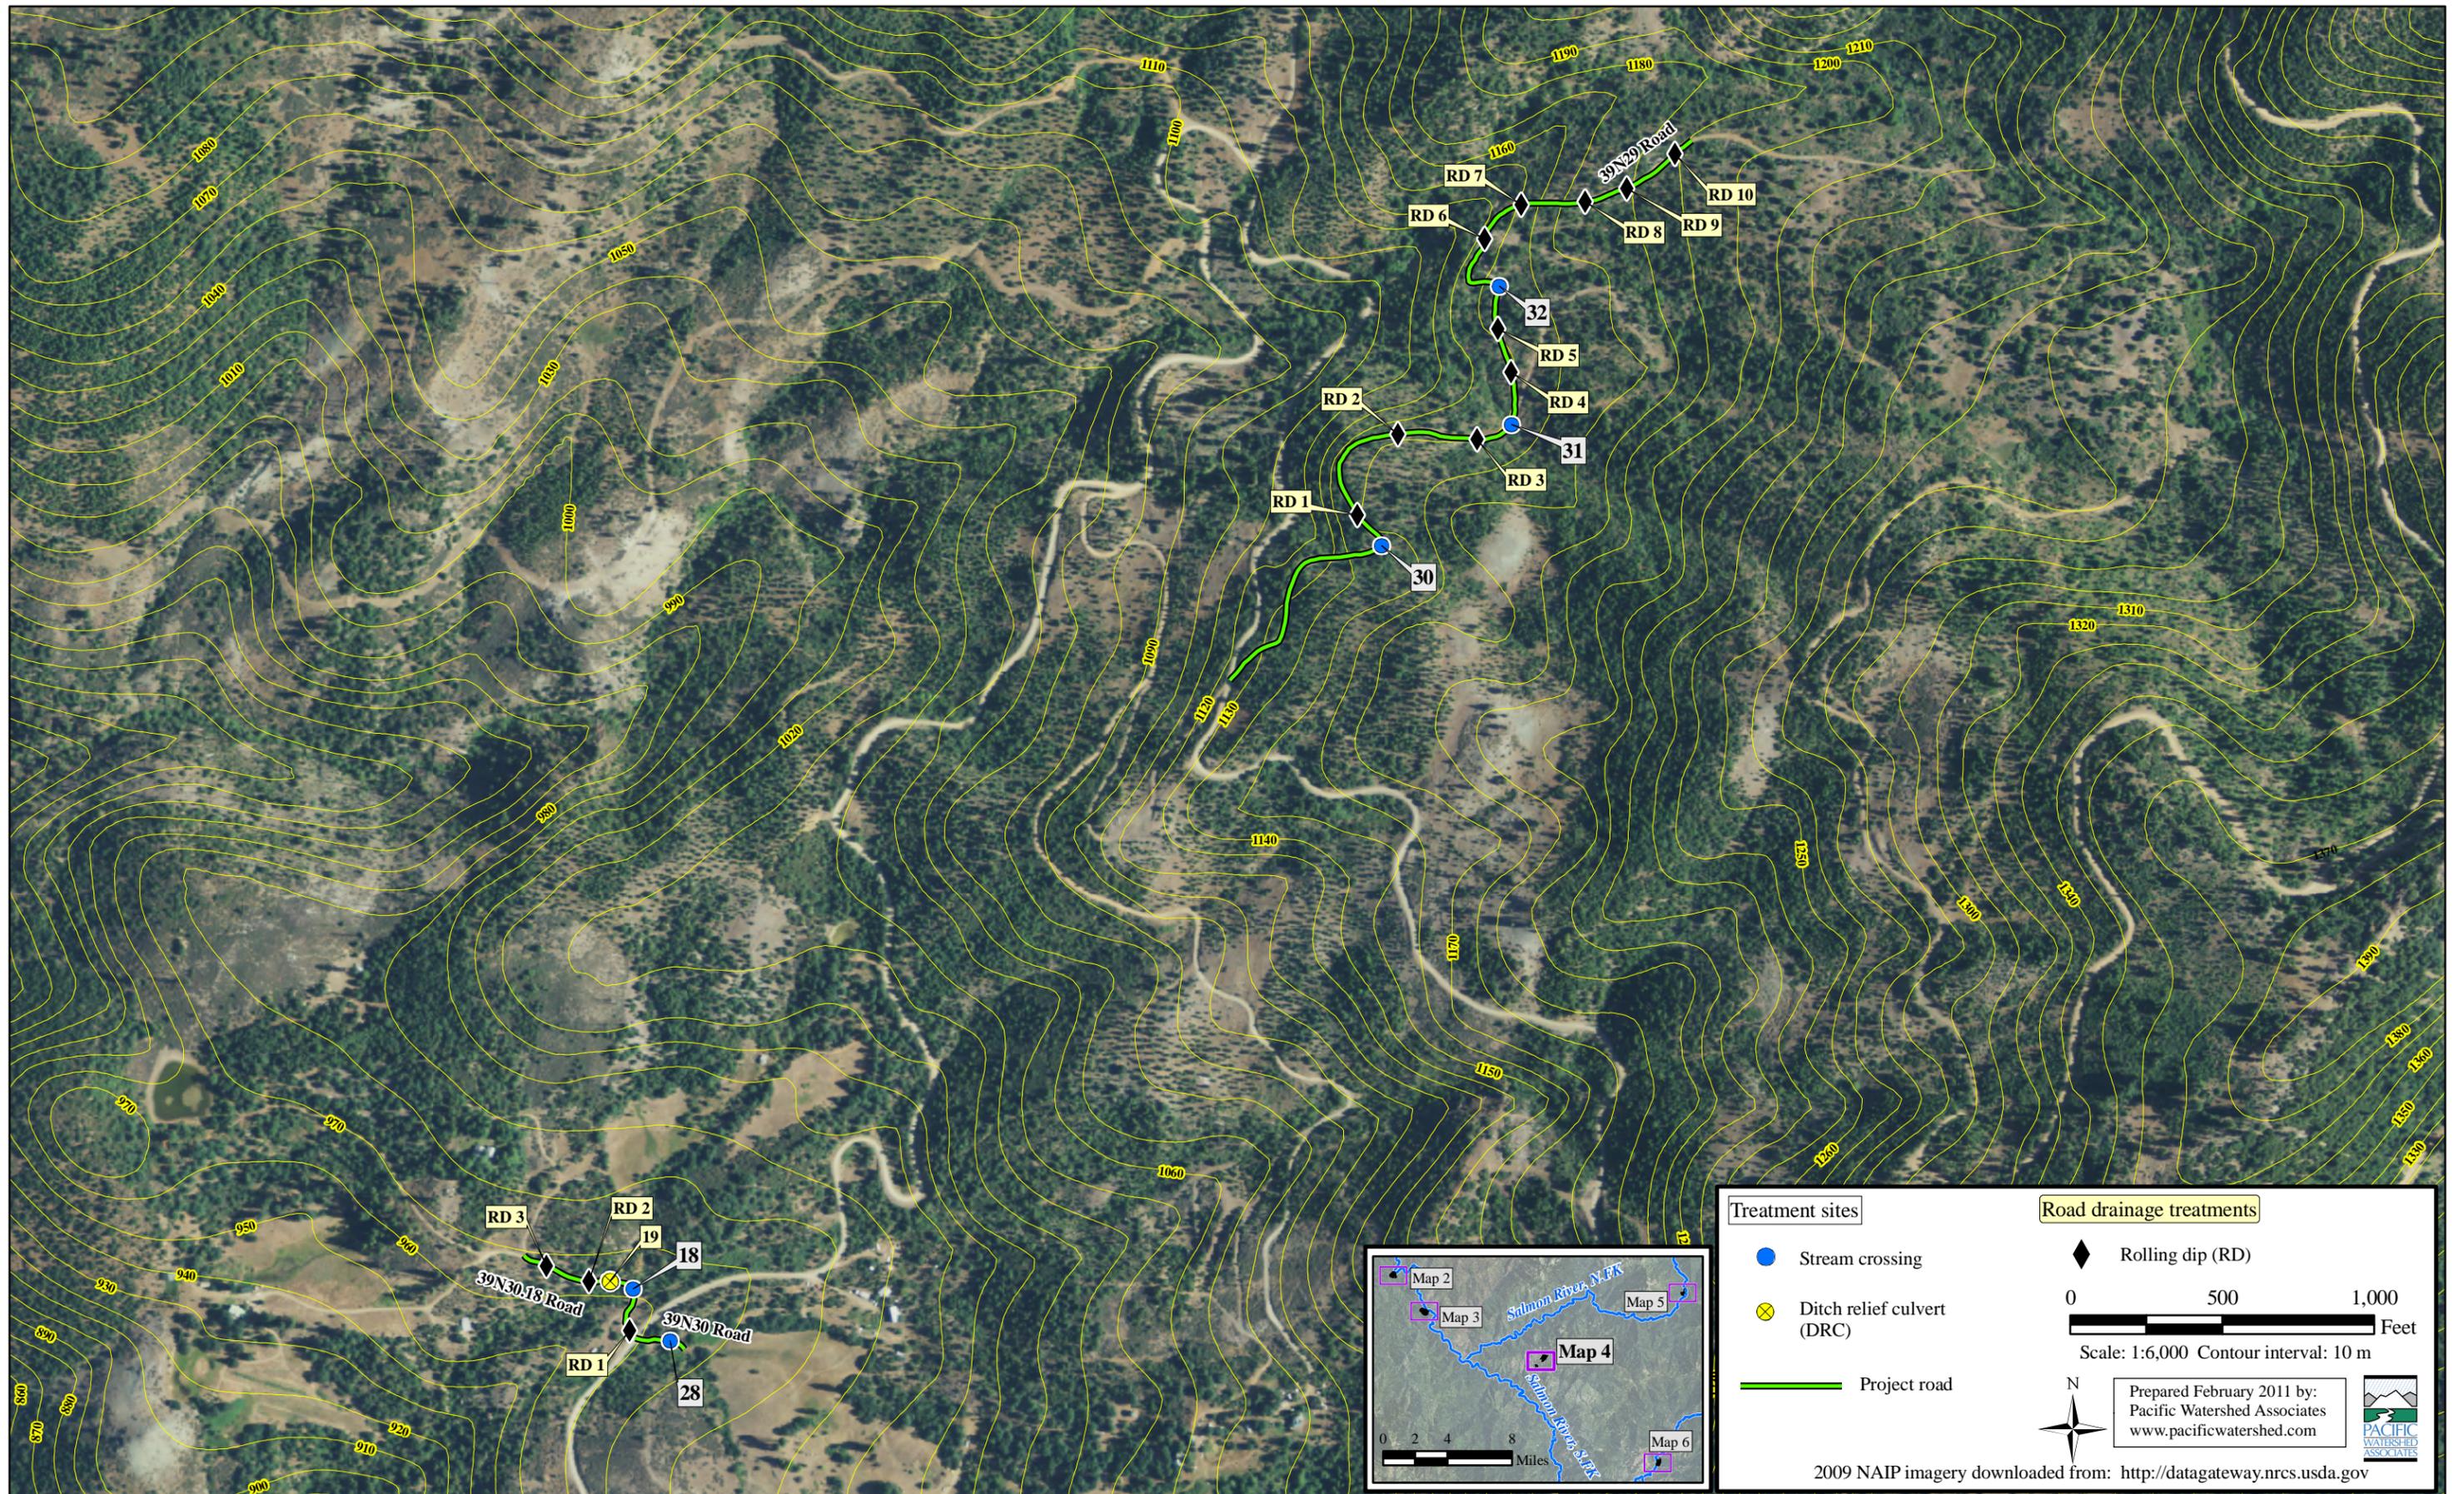
Map 4. Godfrey/Harris Ranch Treatment Area Map, Salmon River Private Roads Sediment Reduction Project, Siskiyou County, California.

3. Godfrey/Harris Ranch: Work completed on the Godfrey/Harris Ranch area included upgrading 3 separate roads; 2 private access roads and one Forest Service access road (Map 4). 39N30.18 Road is a private 0.11mi long access road to a driveway. 39N30.17 Road is a very short 0.02mi long spur leading to a potential building site. 39N29 Road is a 0.58mi long Forest Service road that accesses private property upslope.
4. Finley Camp: Work on the Finley Camp roads involved upgrading two separate segments on adjacent properties. Finley Camp Road #1 is a 0.53mi long driveway and Finley Camp Road #2 is a 0.21mi long access road (Map 5).
5. Cecilville/Taylor: Work on the Cecilville/Taylor property involved upgrading a single 0.49mi long road that accesses private residences (Map 6).

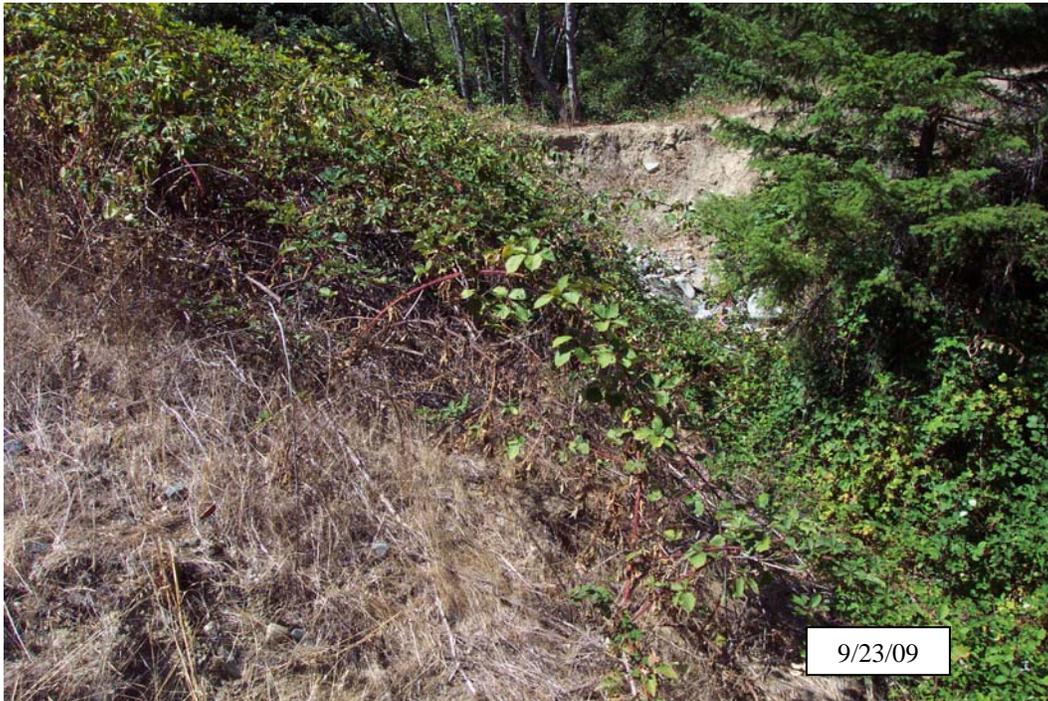
Photo 1a. Bloomer Mine Spur #1 Road, site #3, before implementation. View from the bottom of the site, looking upstream at the crossing of a Class II stream. Prior to treatment, there was no drainage structure at this site and the fill was actively eroding.

0.000	3		A small, failing class II stream. Heavy equipment crews excavated from TOP to BOT. Equipment crews excavated back the sideslopes to 2H:1V for decommission where possible with a 6' wide channel bottom. The left bank was steeper than 2H:1V due to natural bedrock. Spoils were stored locally to right and left.

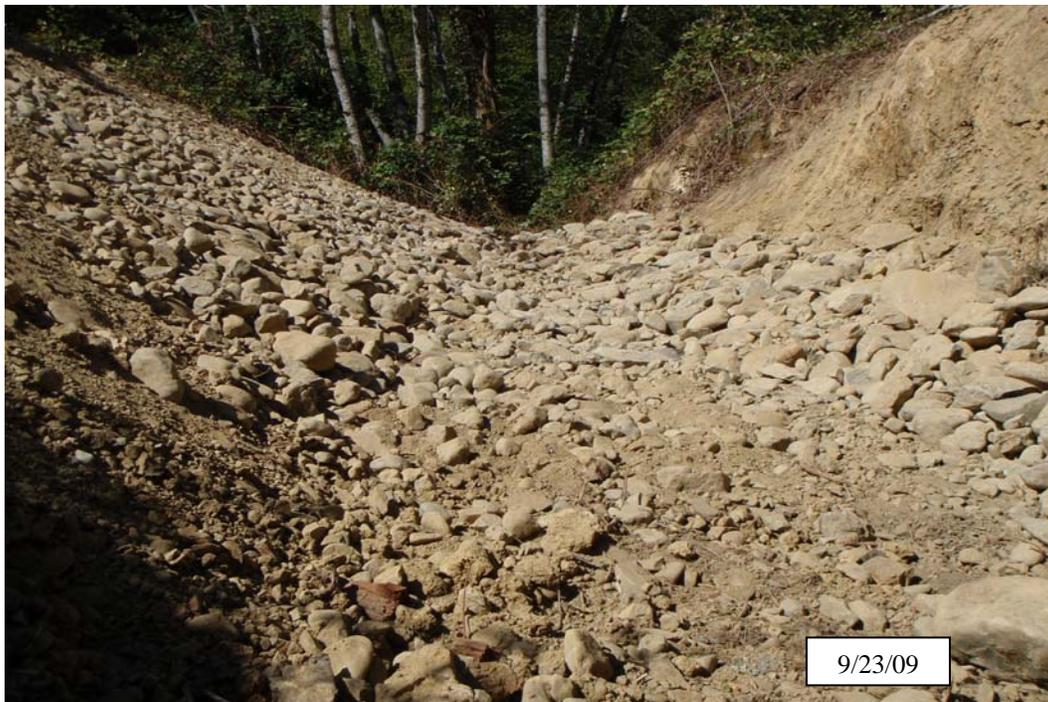
Photo 1b. Bloomer Mine Spur #1 Road, site #3, same view as above, after implementation. The stream crossing has been decommissioned with a 6' channel bottom width and 2:1 sideslopes, except on the left bank where bedrock is exposed. Bare soil areas were mulched with straw after the photo was taken.

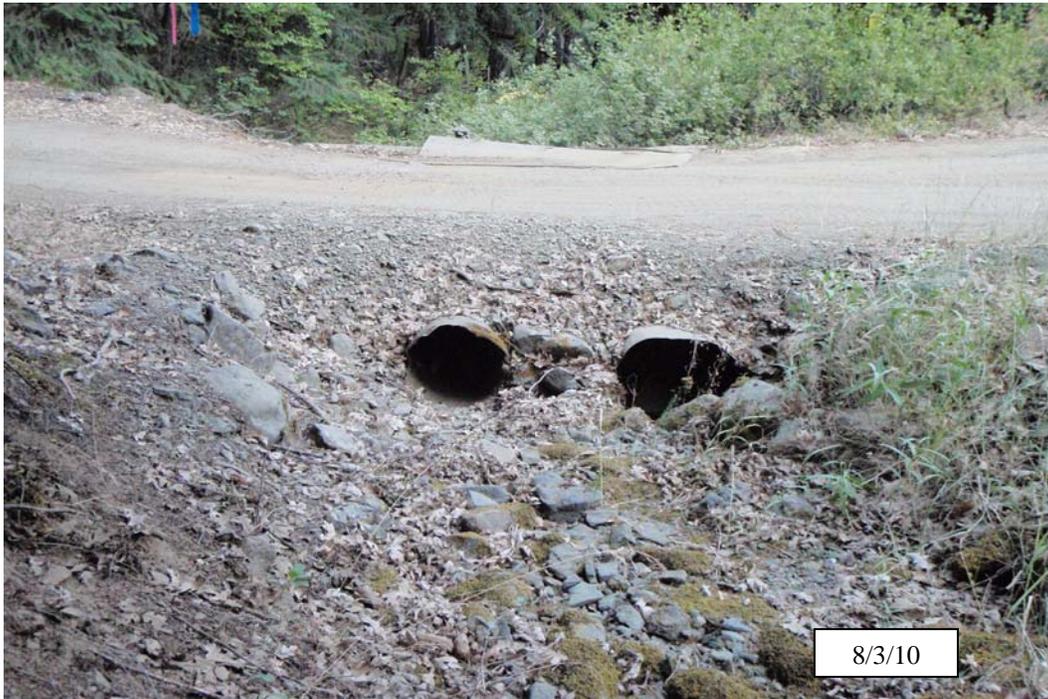
Photo 2a. Cecilville/Taylor Road #1, site #42, before implementation. View from the top of the site, looking downstream at a crossing of a Class III stream. Prior to treatment, there were two, mostly plugged and rusted out culverts at this site. Note the plywood on the outside edge of the road.

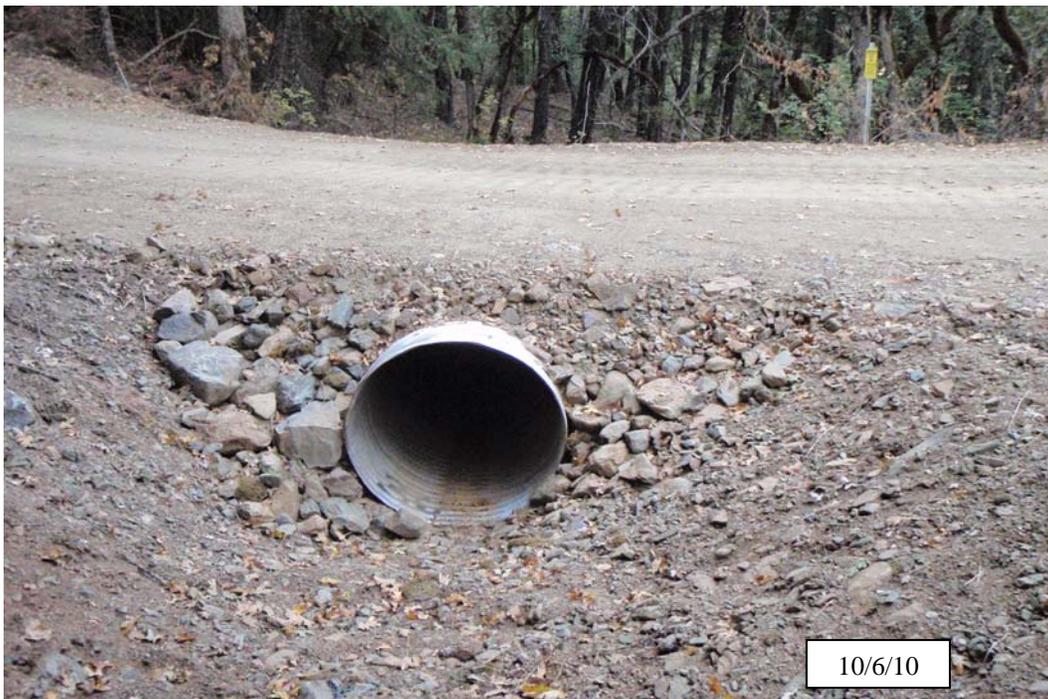
Photo 2b. Cecilville/Taylor Road #1, site #42, similar view as above, after implementation. The channel has been excavated with 2:1 side slopes above the crossing, and a 36 in. diameter \times 40 ft long culvert installed. Rock armor has been placed along the inboard fill for fillslope protection.

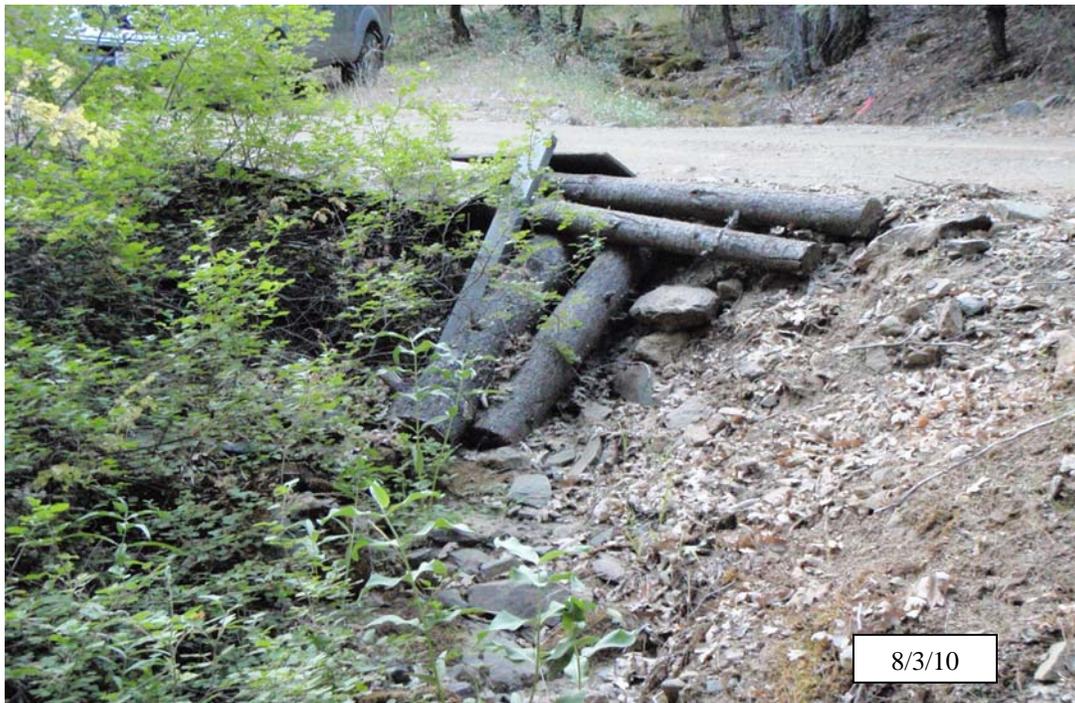
Photo 3a. Cecilville/Taylor Road #1, site #42, before implementation. View from the bottom of the site, looking upstream at a crossing of a Class III stream. Prior to treatment, there were two, mostly plugged culverts at this site and a plywood/debris supported outboard fillslope.

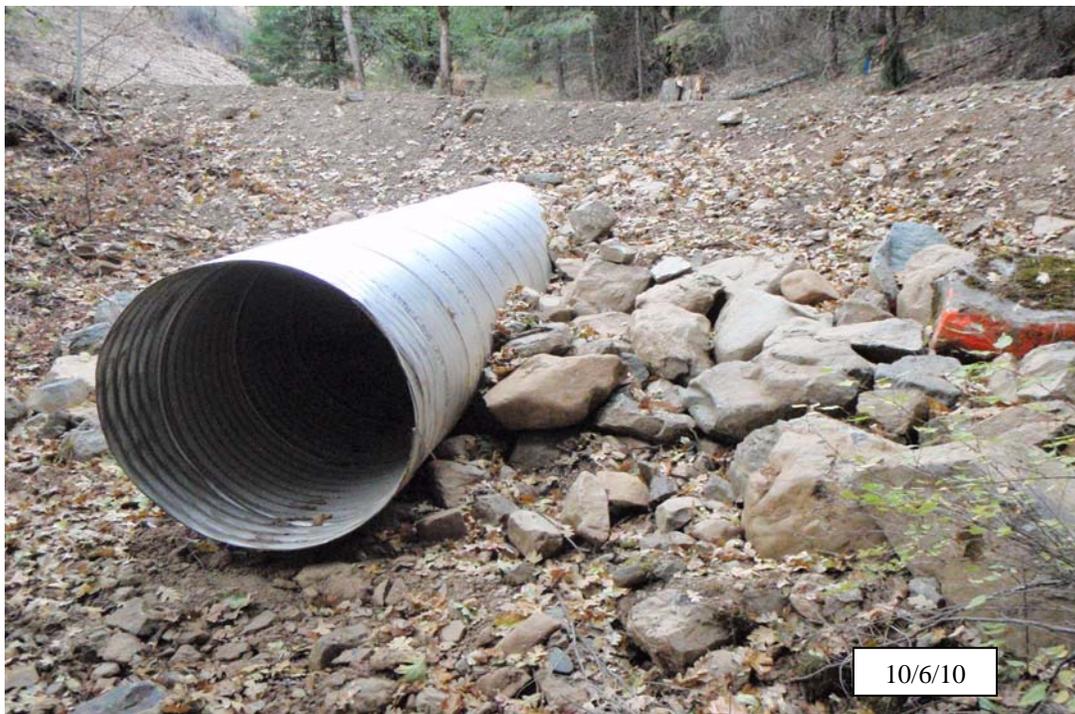
Photo 3b. Cecilville/Taylor Road #1, site #42, similar view as above, after implementation. The channel has been excavated with 2:1 side slopes below the crossing, and a 36 in. diameter \times 40 ft long culvert installed. Rock armor has been placed along the outboard fill for fillslope protection.

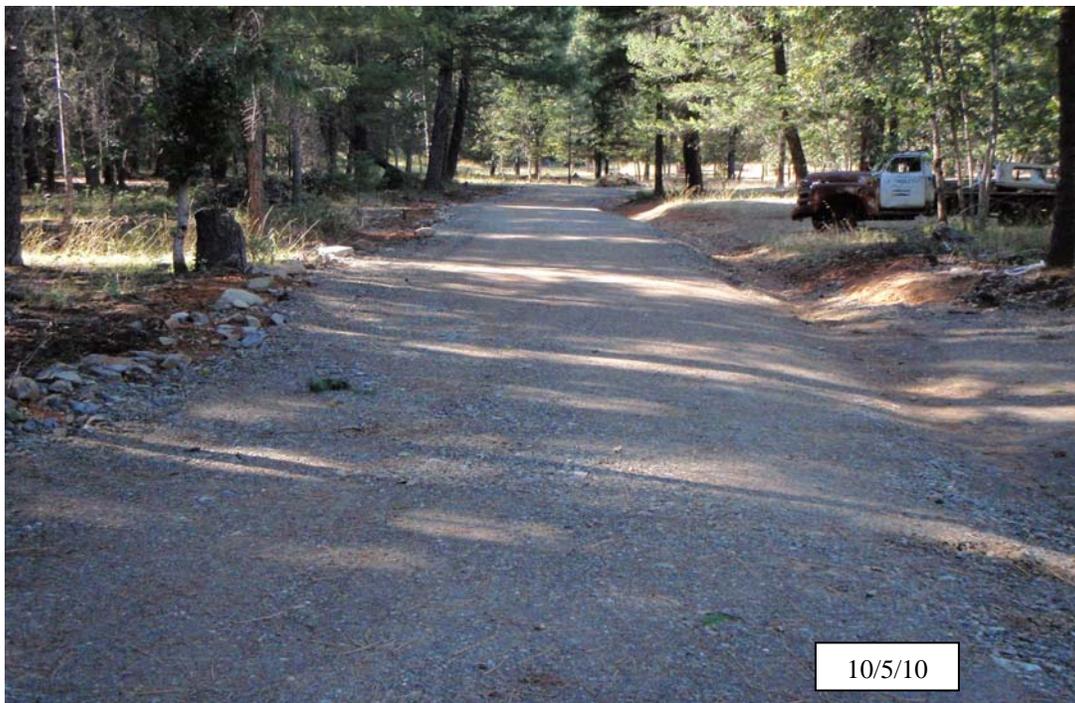
Photo 4b. Finley Camp Road #1, similar view as above, after implementation. The road has been widened and road rock was applied. The inboard ditch (on right) was widened, deepened and armored in order to effectively convey ditch/stream flow through the site.

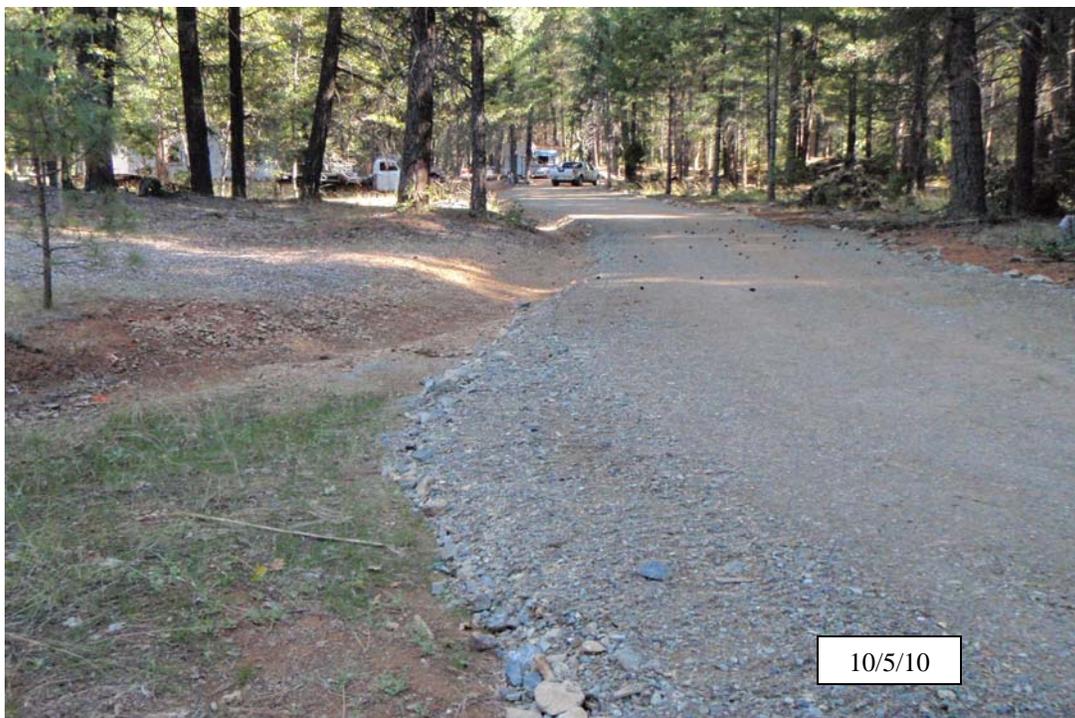
Photo 5b. Finley Camp Road #1, similar view as above, after implementation. The road has been widened and road rock was applied. The inboard ditch (on left) was widened and deepened.

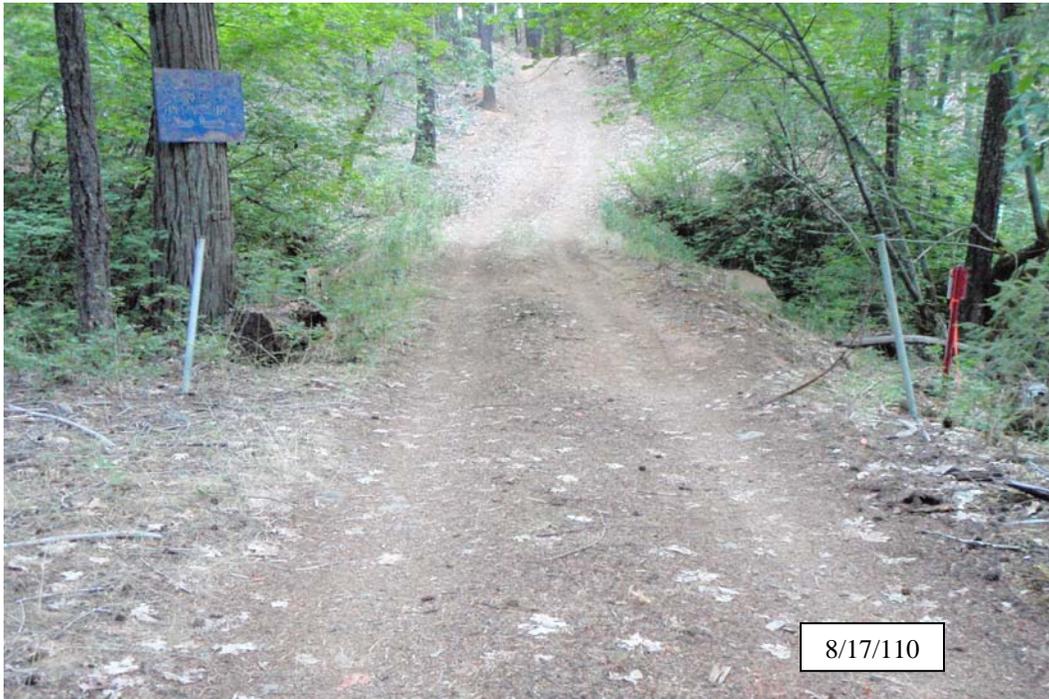
Photo 6a. Finley Camp Road #2, site #36, before implementation. View from the right road approach, looking across this culverted Class I stream crossing.

0.119	36		A large stream crossing with undersized, crushed and rusted culvert. Heavy equipment crews excavated from TOP to BOT, removing the old culvert and installed a 50' flatcar bridge at site. Berms were maintained down left approach and through bridge to discharge flow to RD #1. Equipment crews installed pre-fabricated concrete blocks for abutments to the bridge and installed 40 yds ³ of 2-3' diameter rock armor to each sideslope for bank stabilization.		80 yds ³ 2-3' diameter rip-rap

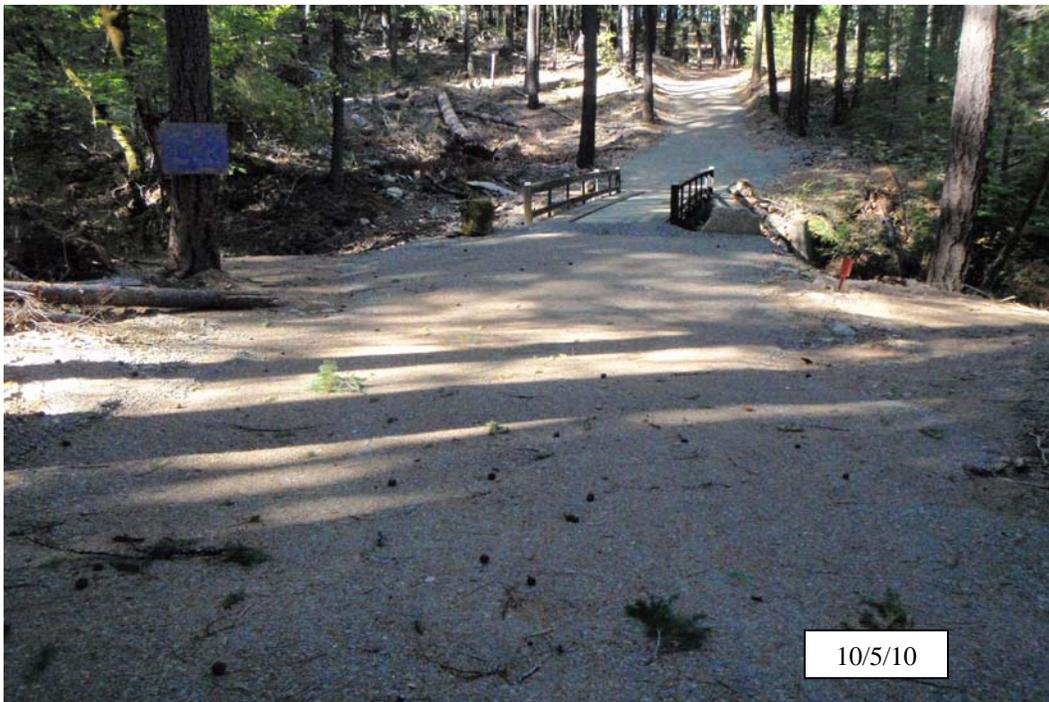
Photo 6b. Finley Camp Road #2, site #36, similar view as above, after implementation. View from the right road approach, looking across the new bridge crossing of the Class I stream. Both road approaches had road rock applied.

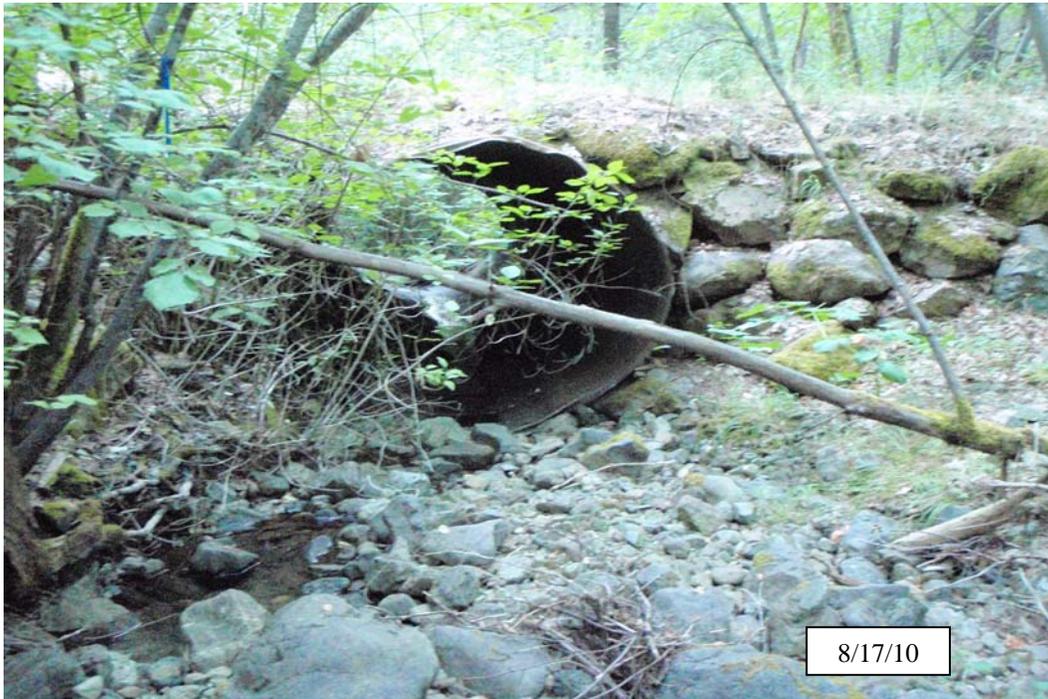
Photo 7a. Finley Camp Road #2, site #36, before implementation. View from the TOP of the crossing, looking downstream towards the old culvert inlet.

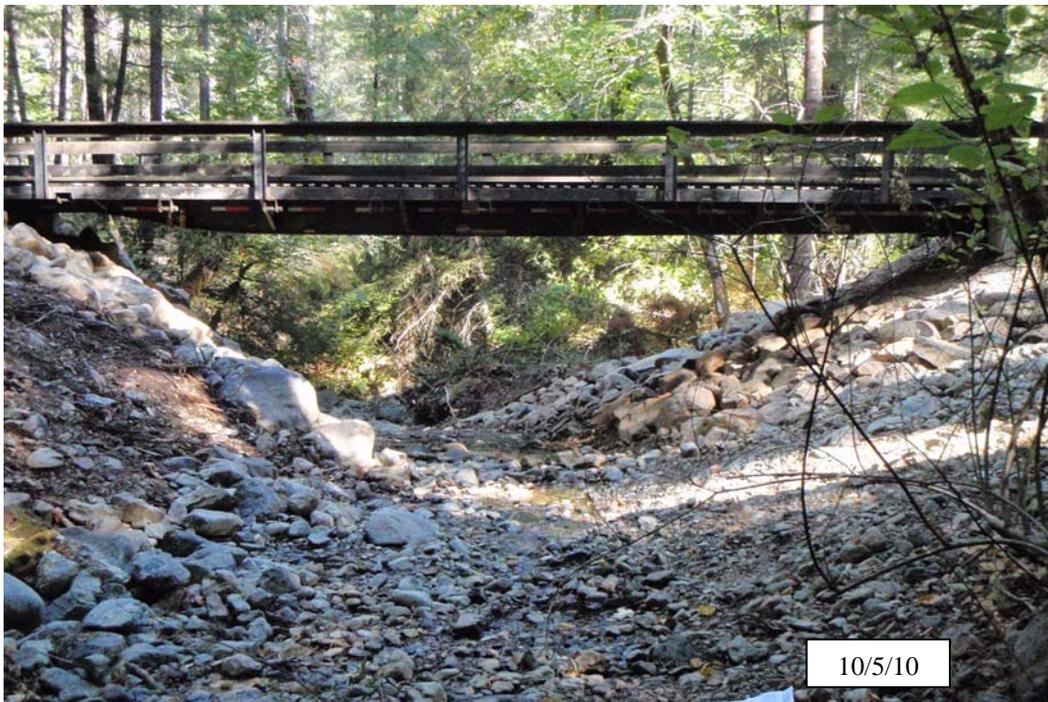
Photo 7b. Finley Camp Road #2, site #36, similar view as above, after implementation. View from the TOP of the crossing, looking downstream at the new bridge. The original sideslopes were exhumed and 40yds³ of 2-3' diameter rock armor was placed on each side to protect the banks from scour and erosion.
