**Salmon River Private Roads Sediment Reduction
Project, Klamath Watershed Restoration Program,
Siskiyou County, California**

PWA Report No. 10087801
June 2011

**U.S. Department of the Interior
Bureau of Reclamation
Assistance Agreement # R10AP20601**

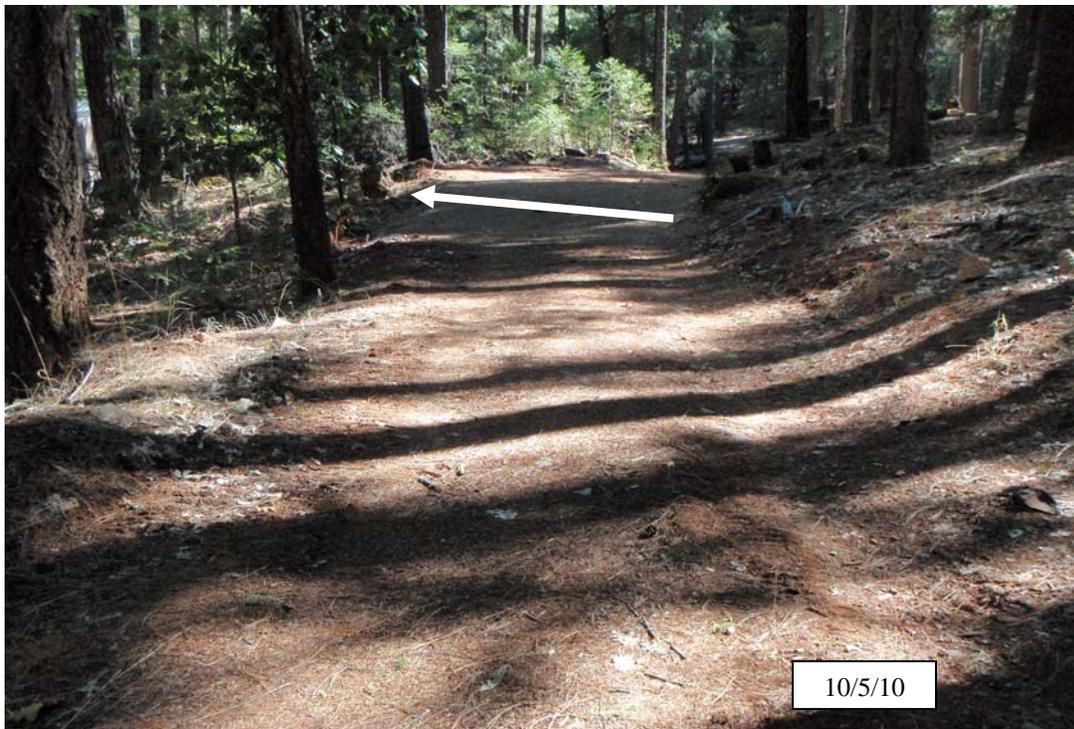
Photo 8a. Finley Camp Road #2, rolling dip location (arrow), after implementation.

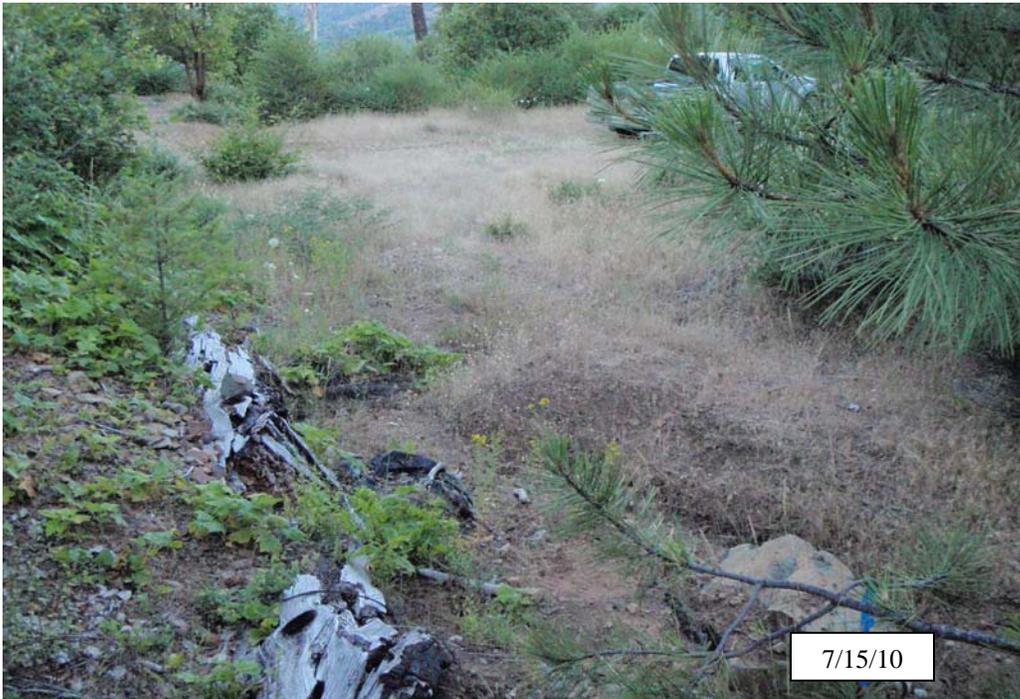
Photo 9a. Godfrey/Harris Ranch, site #30, before implementation. View from TOP of the crossing, looking downstream at the inboard edge of the road.

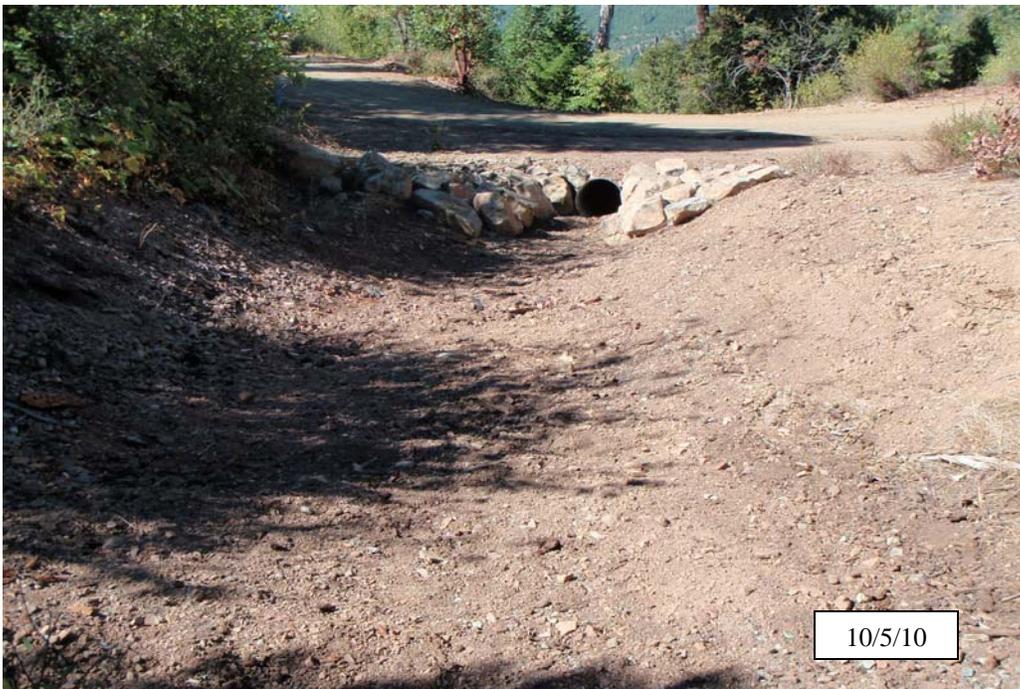
Photo 9b. Godfrey/Harris Ranch, site #30, similar view as above, after implementation. View from TOP of the crossing, looking downstream at the new culvert inlet. The channel has been excavated with 2:1 side slopes above the crossing, and a 24 in. diameter \times 80 ft long culvert installed. Rock armor has been placed at the inlet and outlet for fillslope protection.

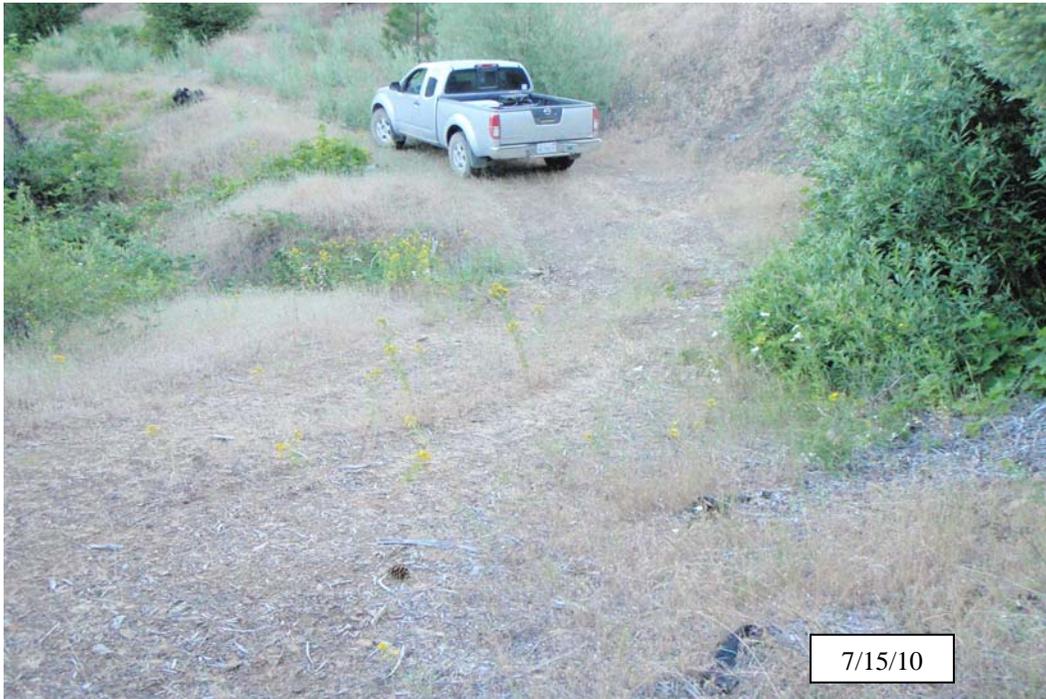
Photo 10a. Godfrey/Harris Ranch, site #31, before implementation. View from the left cutbank, looking downstream across the road prism.

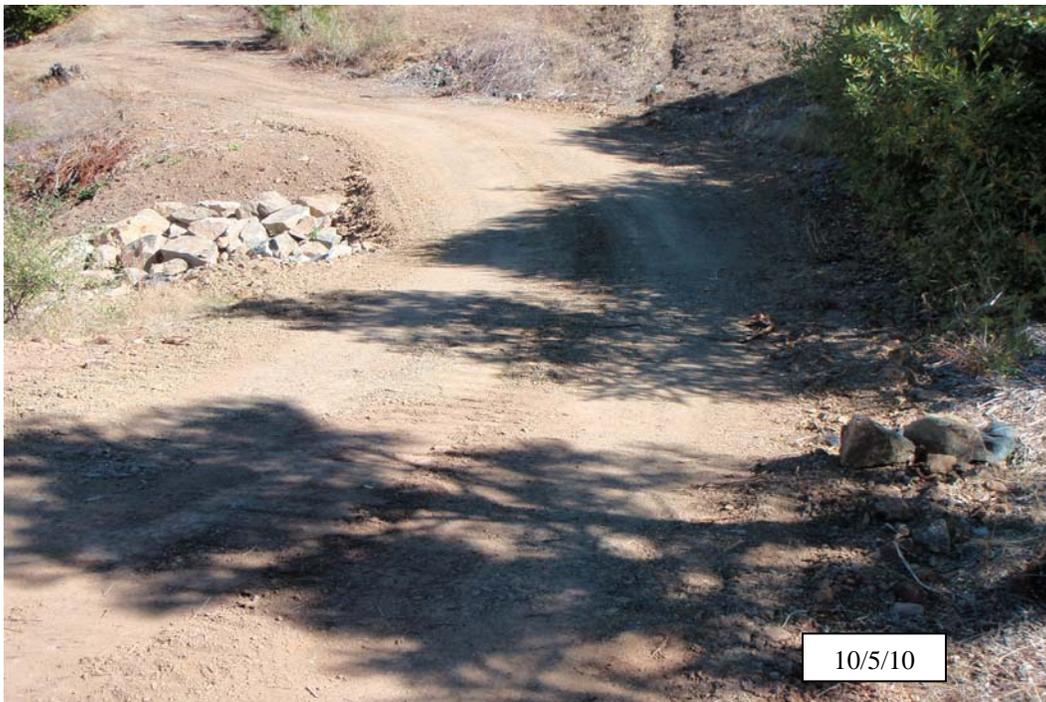
Photo 10b. Godfrey/Harris Ranch, site #31, similar view as above, after implementation. View from the left cutbank, looking downstream across the road prism. An armored fill was constructed by dipping the road and armoring the outboard fillslope.

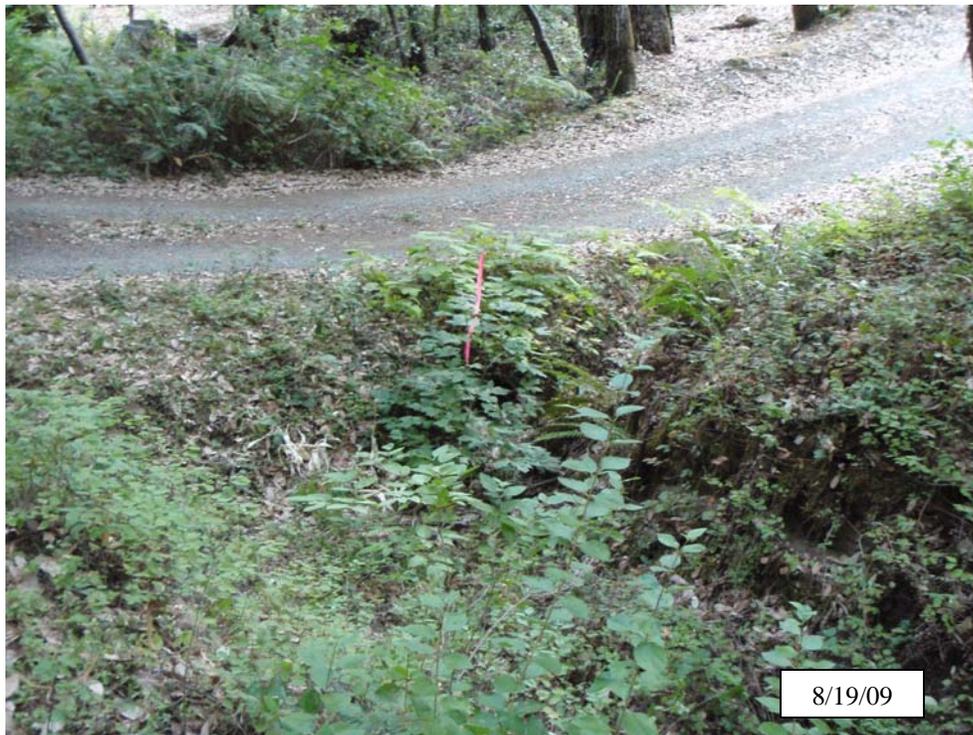
Photo 11a. Butler Flat, site #102, before implementation. View from TOP of the crossing, looking downstream towards the inlet of this undersized and nearly plugged culvert.

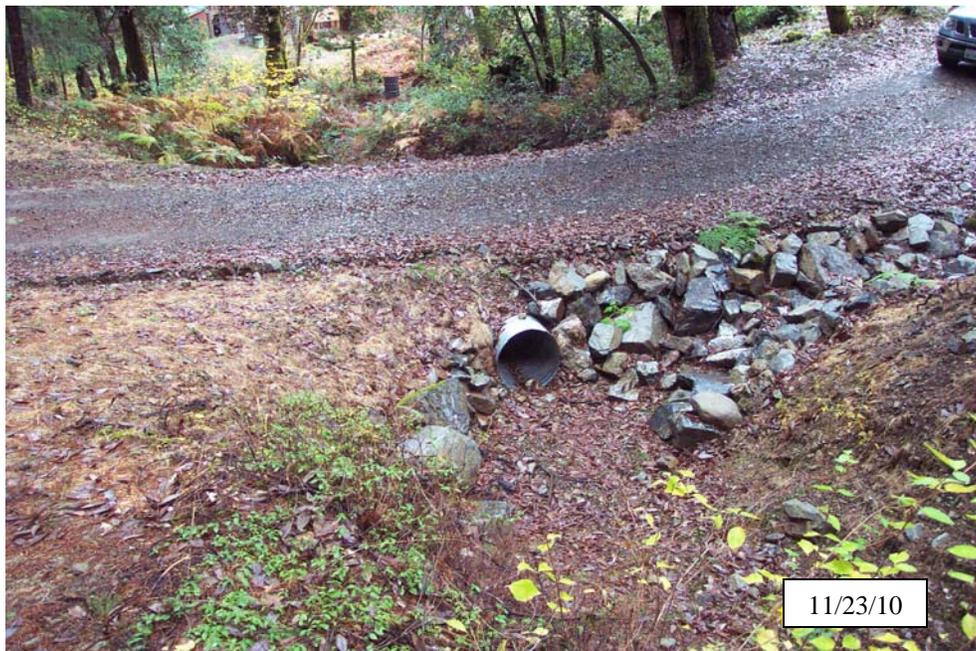
Photo 11a. Butler Flat, site #102, similar view as above, after implementation. View from TOP of the crossing, looking downstream at the new culvert inlet. The channel has been excavated with 2:1 side slopes above the crossing, and a 24 in. diameter \times 30 ft long culvert installed. Rock armor has been placed along the right approach, lead-in inboard ditch to minimize future scour from an active spring.

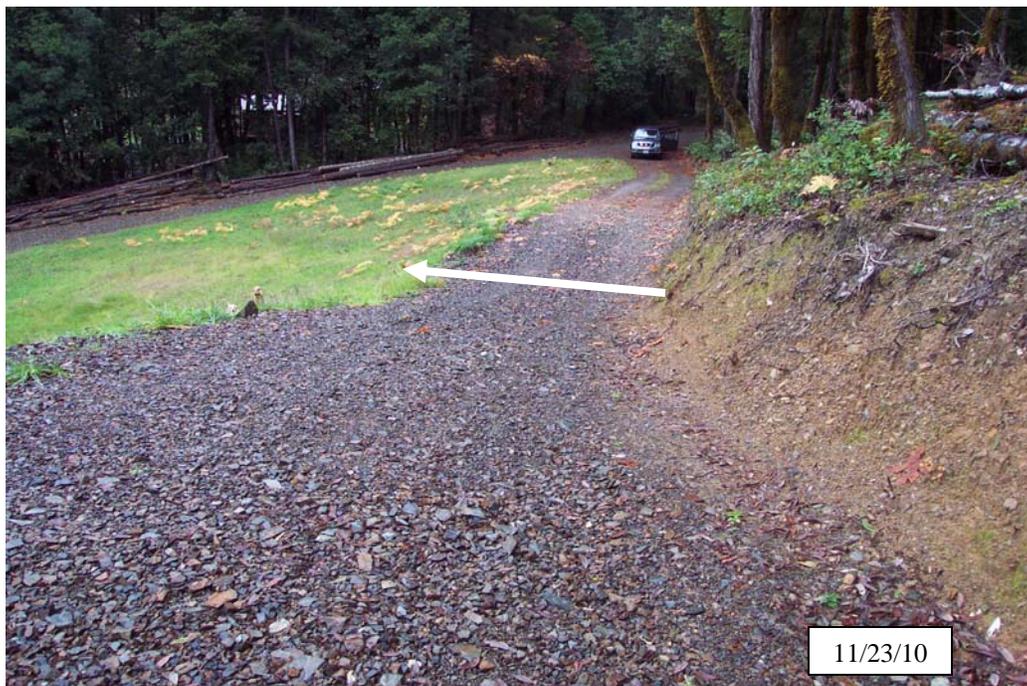
Photo 12b. Butler Flat loop Road, rolling dip # 3.1 location (arrow), after implementation.
